Tanvir Tanim, Senior R&D Scientist and Group Lead
Energy Storage Technology Group, U.S. Department of Energy
Energy Storage and Electric Transportation

A Teardown Study of Flood Damaged Electric Vehicles

EV Battery Safety, Part 2

SAE Government/Industry Meeting
January 16-18, 2024, Washington, DC, USA

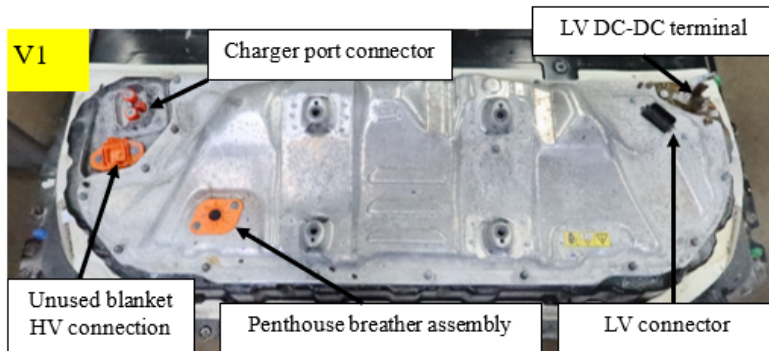
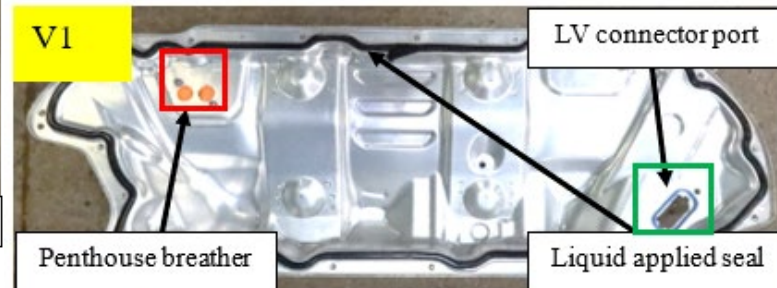
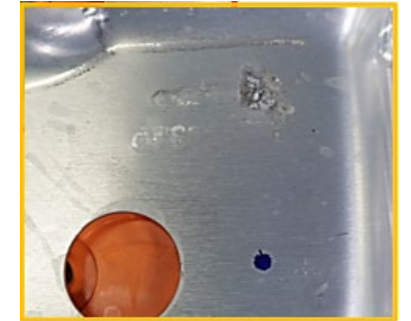
The Penthouse

- The exterior side of the penthouse shows signs of submersion resulting in various levels of corrosion for all four EVs in this design group.
- The low voltage DC-DC converter terminals are exposed on the penthouse and as a result exhibited particularly severe corrosion resulting from galvanic activity.
- The underside of the penthouse lid shows what appears to be residue of dried liquid in two distinct areas, which may be indicative of either condensation or some level of water ingress in V1 and V2.
- Those areas are surrounding or adjacent to the penthouse breather vent and low voltage communication connector.
 - The interior surroundings of the low voltage connector opening (silicone seal) in V2 shows witness marks.

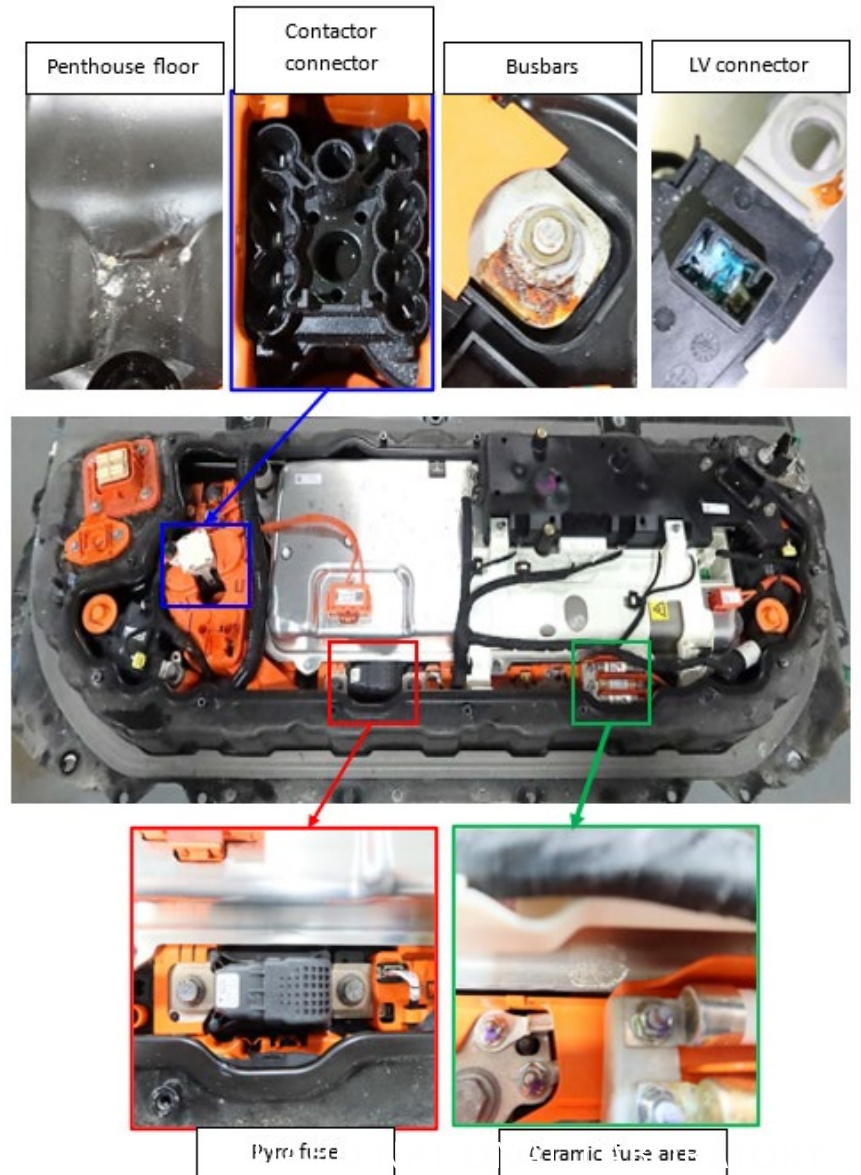
The Penthouse

- Distinct corrosion, contamination, water, and water marks on the floor of the penthouse and within several components for V3 (Tesla Model 3) were observed:
 - More specifically, corrosion was noted on the busbar connections, within connectors, on the uncoated aluminum housing of the charger/inverter module, and elsewhere
 - Contactors tested the open-circuit (normal) and found the pyro-fuse had not triggered.
- In this state, it is highly likely that the modules within the penthouse would be unable to function properly in any capacity.

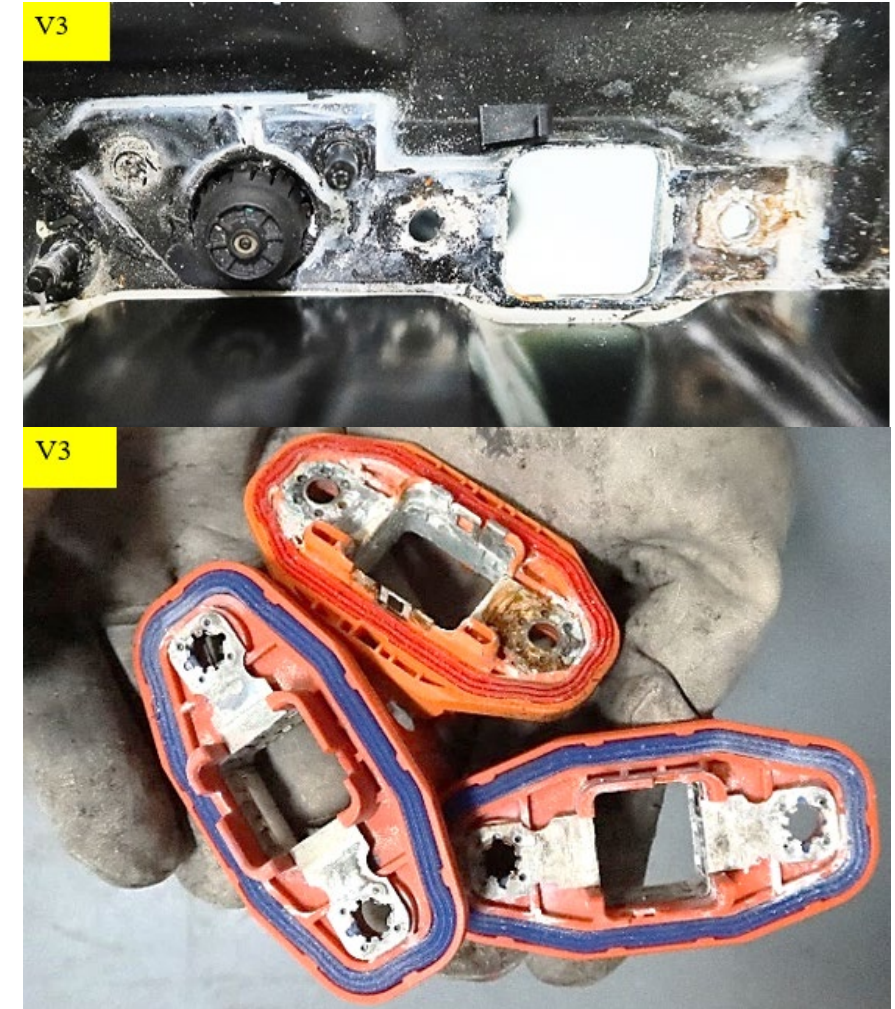
Connectors

- For V3 (Tesla Model 3), the high voltage connectors of the electronics penthouse were observed to have a high degree of corrosion throughout. The internal surface of the pack where the connectors mount also showed a large amount of contamination.
- The interior, sealed area of the low voltage communication connector on the penthouse of V1 (Tesla Model Y) exhibited what appears to be the dried residue of water intrusion and remnants of light corrosion or contamination surrounding the bases of several pins. Similar corrosion was found on the corresponding terminals of the vehicle wire harness.

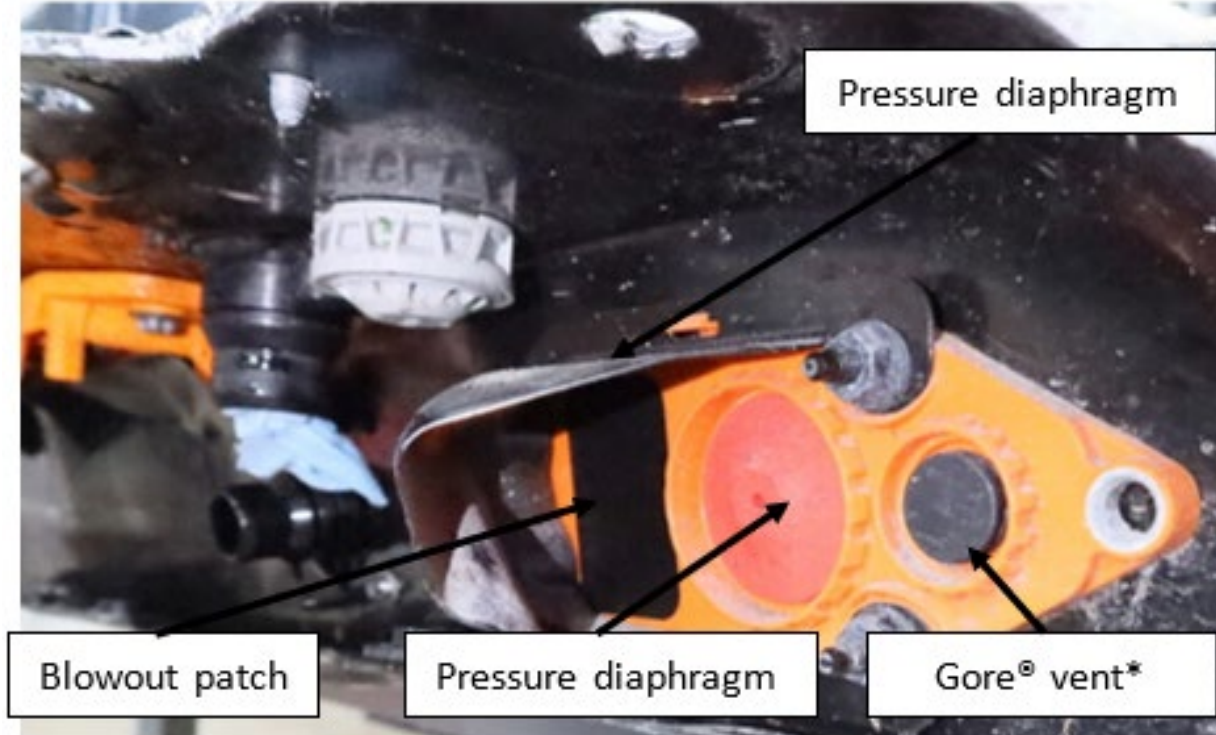
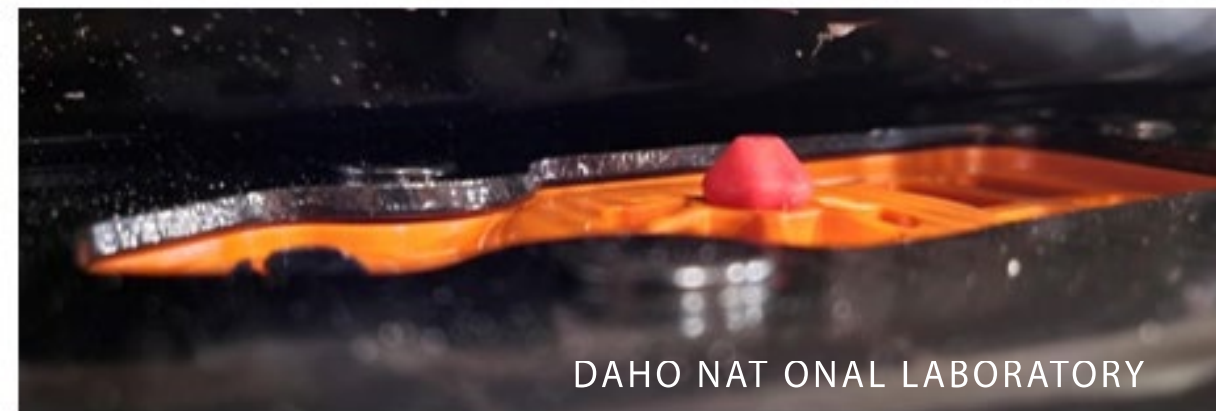
Battery pack vent assembly

- Examination of the exterior and interior of the vent assemblies for all the vehicles in this design group shows no signs of seal failure or water ingress through the pressure diaphragm.

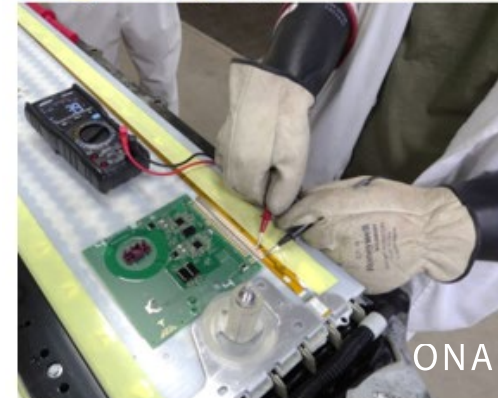
Pack Compartment

- In general, the pack voltage remains elevated even after more than ten months of storage:
 - Except for V3 (Model 3), the maximum cell group voltage variation remained within 14 mV.
- The Module 3 of V3 measured 3V lower than the identical Module 2. Cell group voltage testing revealed cell group 11 within Module 3 measured 1.06V vs the average cell group voltage of approximately 4.00V.
 - The over-discharged cell group was consequently located, and surrounding materials were removed, and no evidence of any physical damage or watermark was found. The absence of any evidence of water induced damage indicates manufacturing/aging related issues within cell Group 11 that became pronounced when the BMS balancing system was non-operational upon failure of the 12V system.

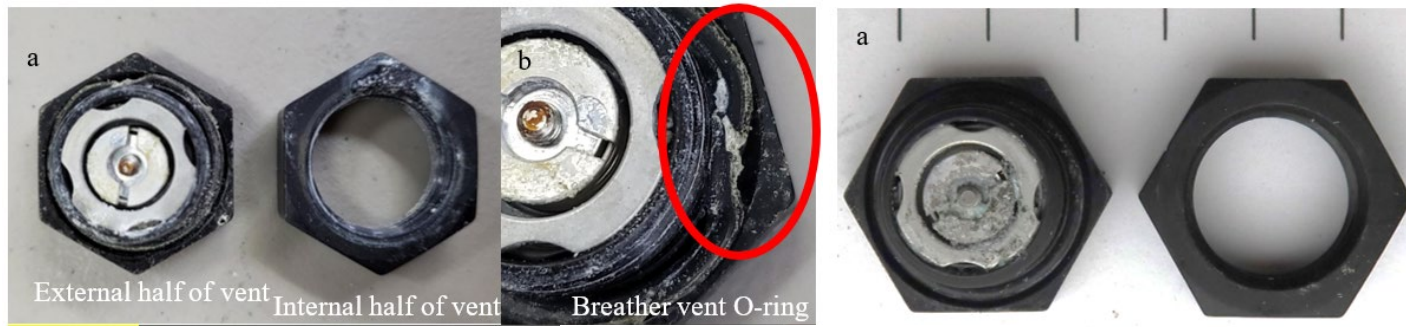
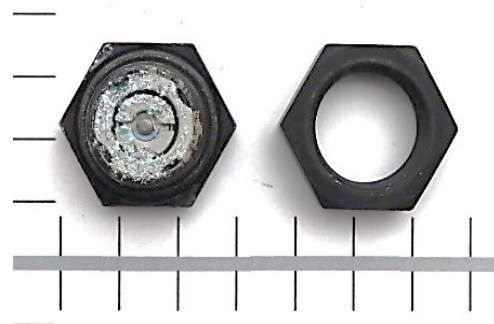
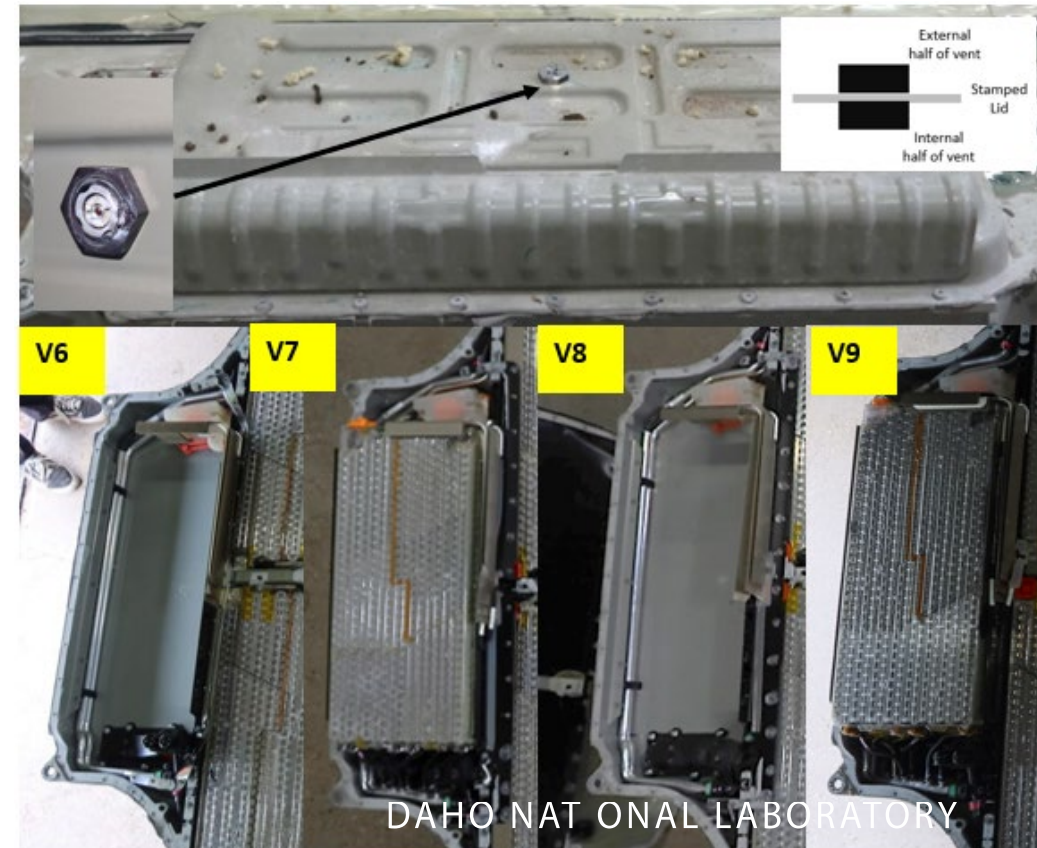
Penthouse Breather Vent

- There is a mechanical breather vent located on the lid in the center of the penthouse of V6 (Model X), V8 (Model X), and V9 (Model S). Vehicle V7 (Model X) did not have a breather vent.
- Water ingress and contaminants were observed in the floor of the penthouse space of V6, V8, V9, directly below the breather vent on the lid due to its failure:
 - Modes of vent failure: Compromised section of the O-ring (V6), internal failure (V8 and V9).

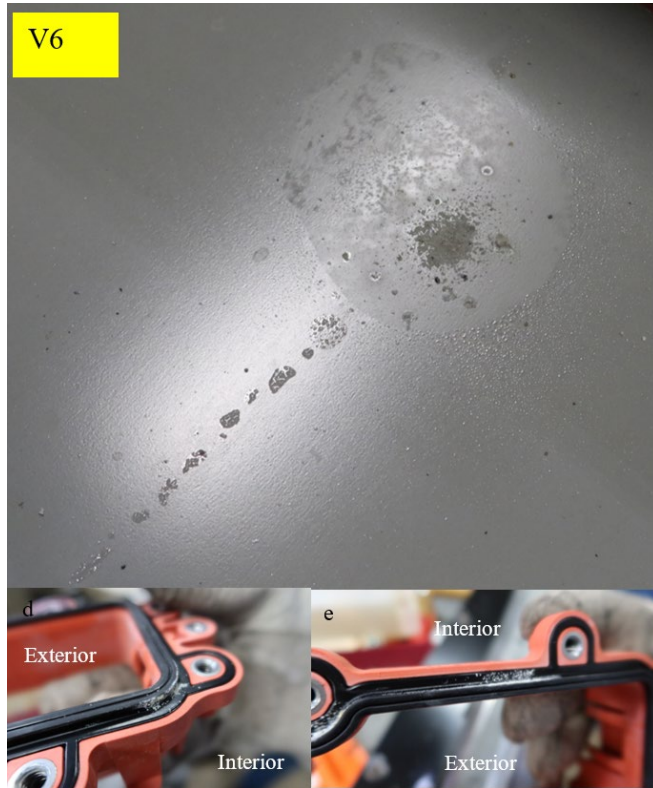
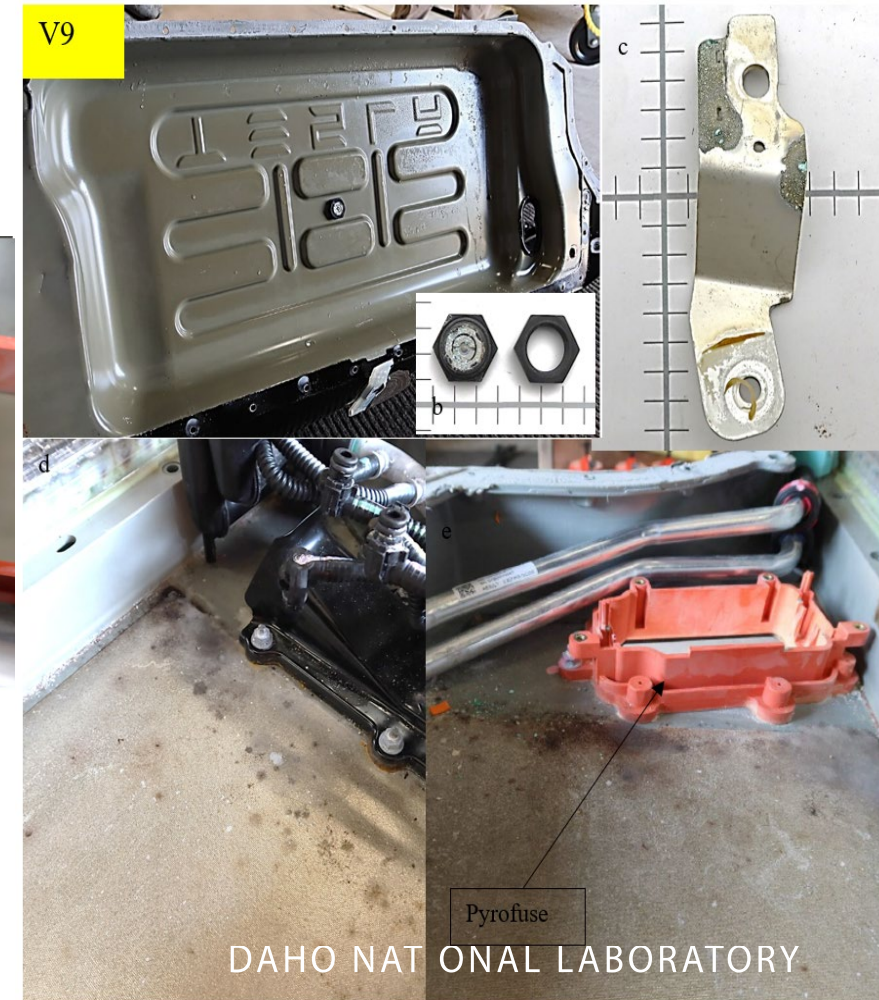
Penthouse Breather Vent (cont.)

- Pictures showing evidence of watermark/sediments, condensation, corrosion, and mold growth.
- V9 pack had water condensation throughout the pack, resulted in distinct corrosion.

The presence of sediment deposits exclusively on the interior side of the pyrotechnic fuse, suggesting that the source of the liquid that encountered the seal is somewhere inside the pack penthouse.

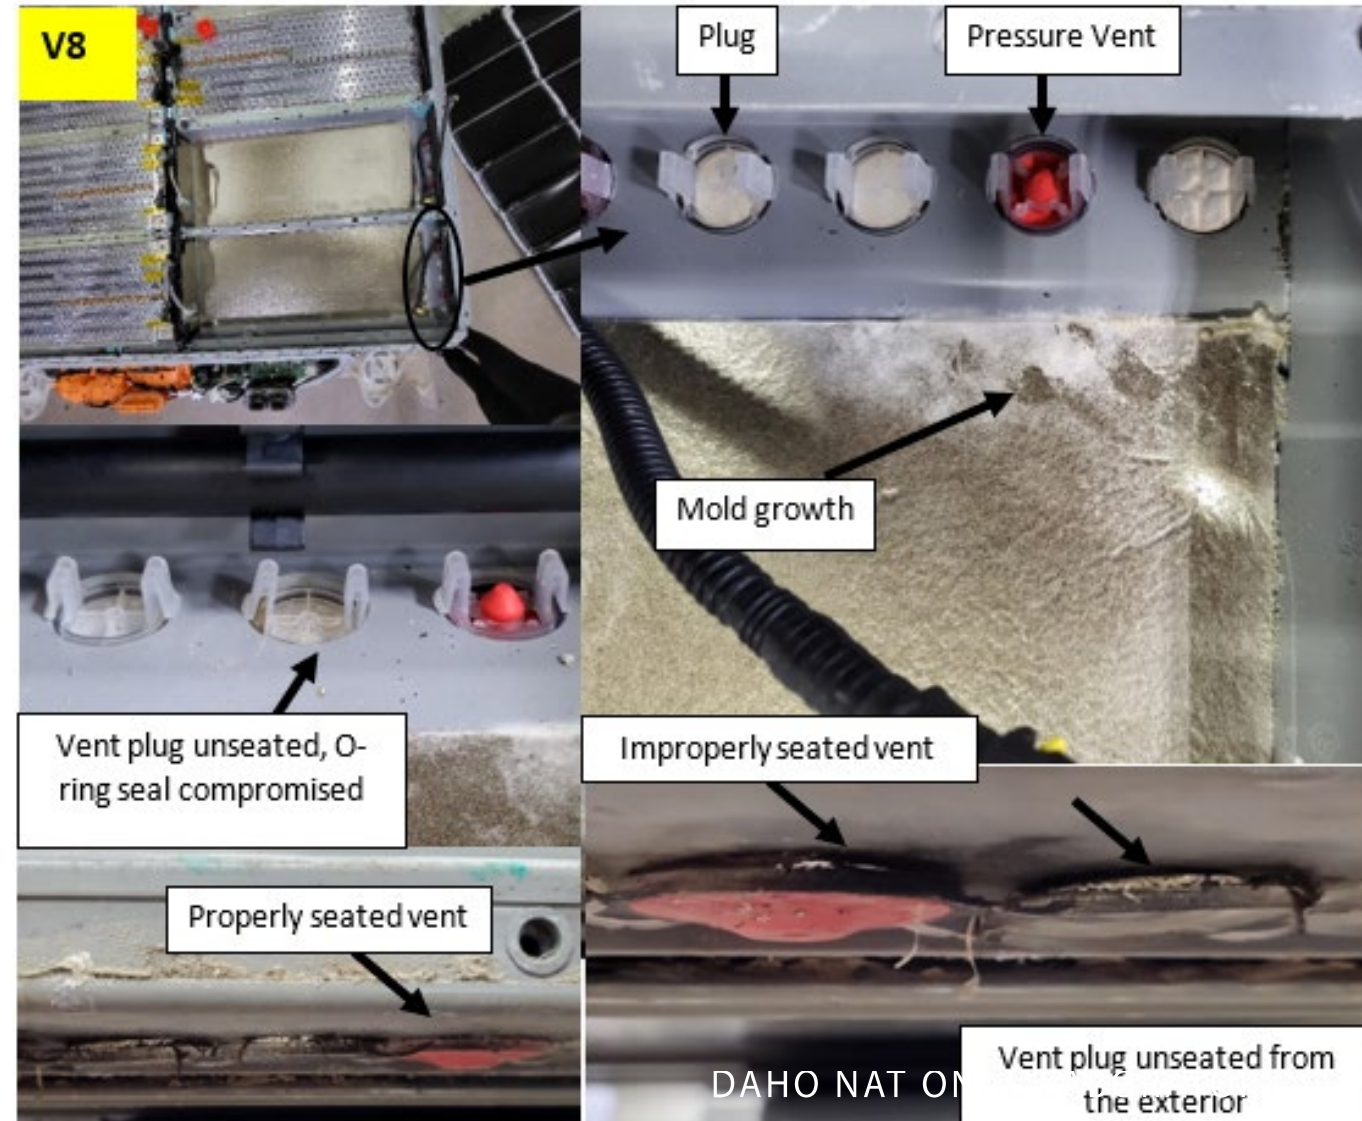
Outboard Vents and Plugs

- The side sills of the battery pack for this design group feature snap-in pressure vents and vent hole plugs, each of which seal against the battery pack tray with an O-ring:
 - Close examination of the interior side of the vents revealed certain instances where the retaining features of the snap-in vent bodies had failed, resulting in the vent or vent plug becoming unseated in its hole, thereby compromising the integrity of the O-ring and allowing water ingress
 - Not every component had been unseated from the interior as shown in the figure, rather the exterior faces of the other compromised vents revealed slight misalignment that may have contributed to a compromised O-ring seal.

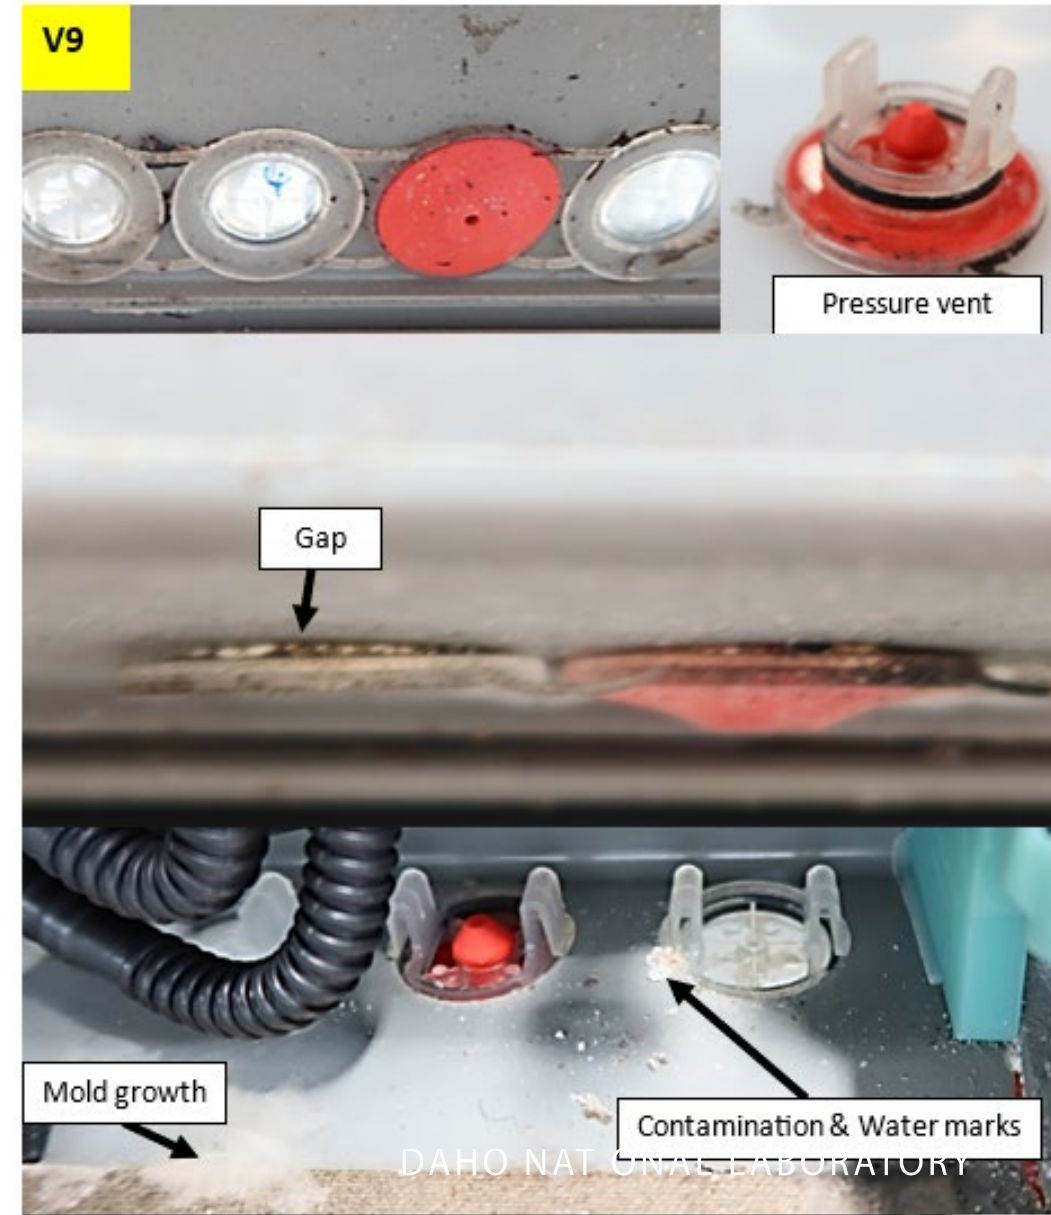
Outboard Vents and Plugs (cont.)

- For vehicle V9 (Model S), every module space within the battery pack displayed signs of water contamination – water, water marks, sediment/residue, and/or mold:
 - These vents and plugs showed varying degrees of evidence of contamination and may be a primary source of water intrusion within the non-penthouse area of the pack of V9.
- For V6 and V7, the plugs and vents were uncompromised.

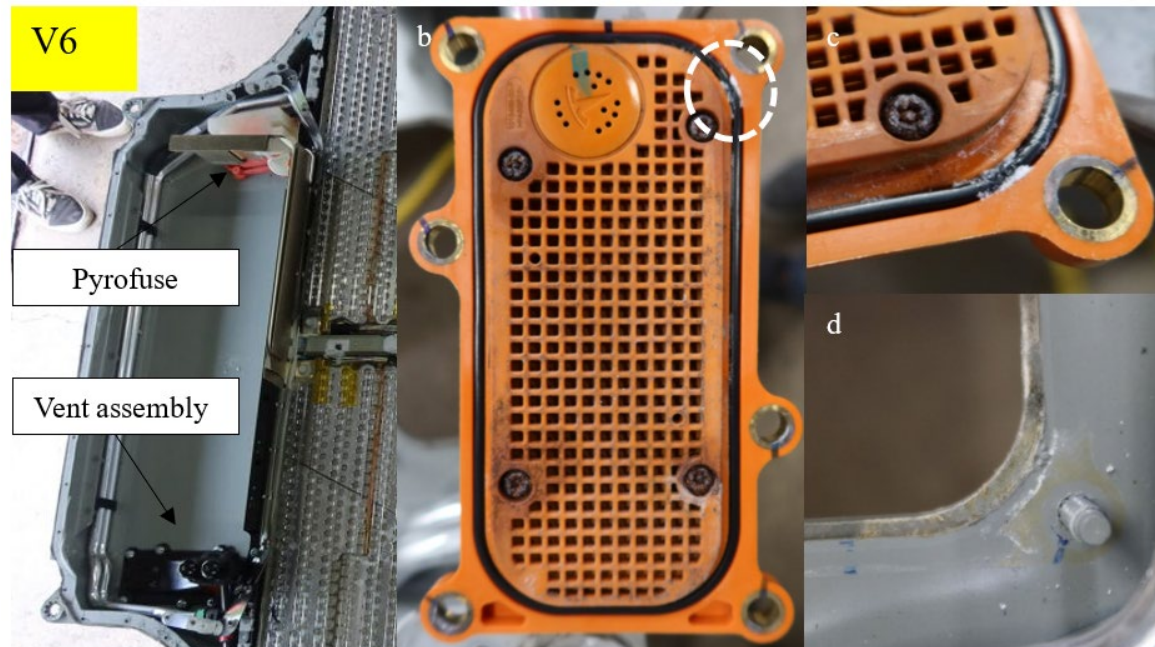
Battery Pack Vent Assembly

- Upon removal of the vent of V6 (Model X), sediment deposits were observed in a localized area of the injection molded seal:
 - The sediment was present on both sides of the seal.
 - Given the proximity of the breach to exclusively one of the studs used to fasten the vent to the pack, it is possible that insufficient fastener torque resulted in a local reduction in compressive force on the seal, causing this localized leak.
 - The vent assembly of vehicles V7, V8 and V9 is found to be uncompromised.

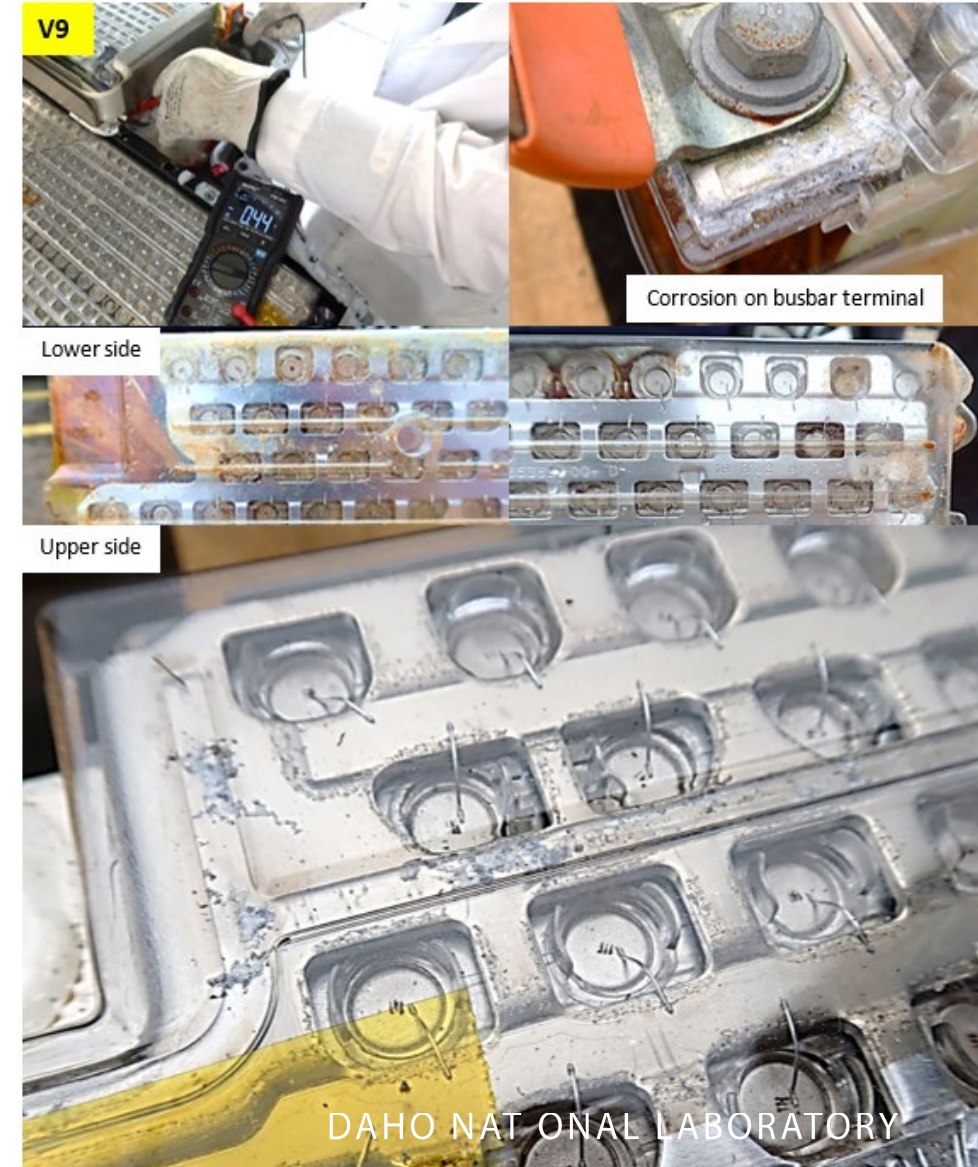
Battery Module in Penthouse Compartment

- Both Modules M8 and M9 were located directly underneath the penthouse breather vent that failed:
 - The lower battery module, M8, within the penthouse and measuring a mere 0.4V shows evidence of prolonged and severe water contamination, as indicated by large amounts of corrosion and residue throughout the module. Hence, Module M8 may be nonfunctional, unsafe, and completely unsuited for operation

- The source of the water exposed to this module would appear to be the breather vent on the top of the penthouse lid, which sits directly above both M8 and M9. Given that M8 is located at the bottom of the pack, water likely collected and caused the short which discharged the module. Though also contaminated and corroded, the upper module, M9, voltage measured in line with the remainder of the modules, therefore, it is presumed the water intrusion flowed over the upper module and left it unaffected in comparison to the lower module, which dwelled in the accumulated water.

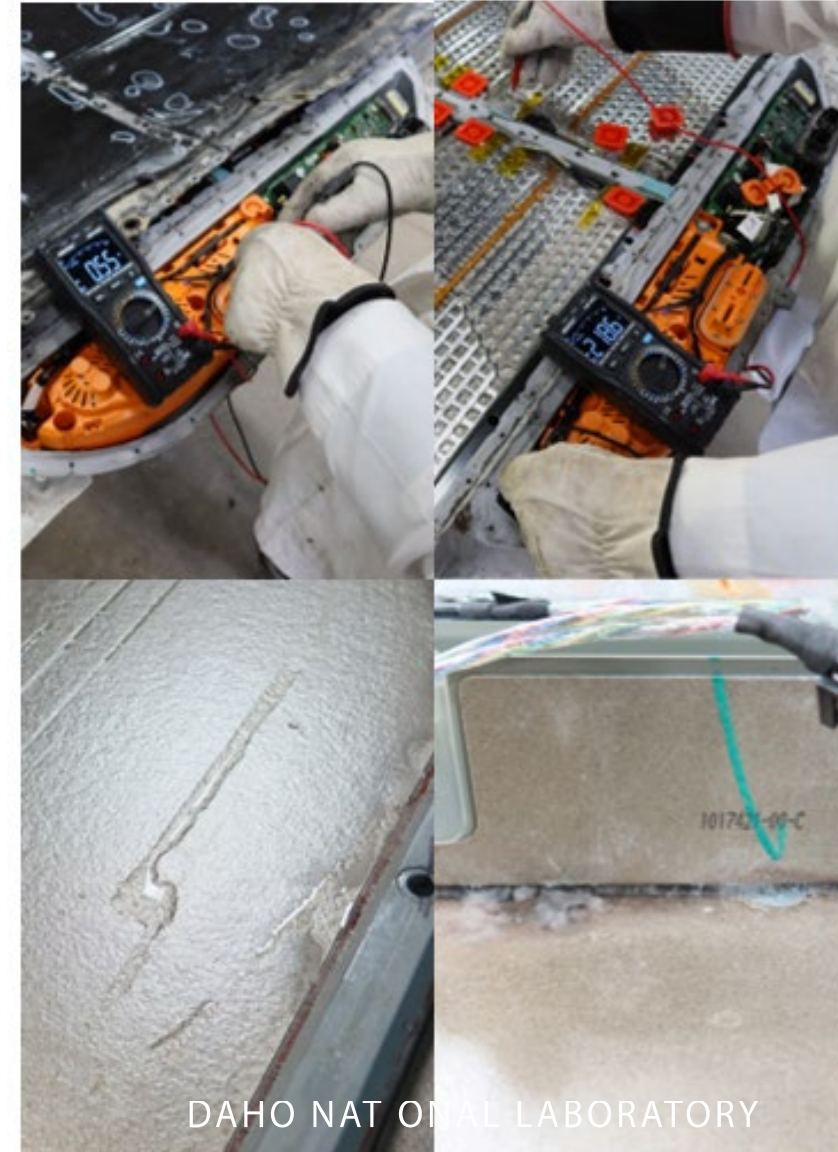
Battery Pack

- Isolation fault within the battery of V9 (Model S):
 - While testing for isolation faults by measuring HV connector and module-to-chassis voltages, various abnormal results were observed. These were: (i) a voltage of 0.55V between the external high voltage terminals with contactors open, (ii) a voltage measurement of 218.6V, between battery module M1 to the battery chassis prior to busbar removal, and (iii) 3 to 9V from individual modules to battery chassis after busbars had been removed.

- The apparent source of the isolation fault appears to be contamination on underside of modules – even with all busbars disconnected and removed, voltage/continuity between module terminals/current collectors and battery chassis was observed.

- The front of the pack uses aluminum tubing to carry ethylene glycol coolant to the main inlet/outlet ports on the pack lid. Corrosion/crystalline material was observed on the aluminum tubes which contacted the pack tray.

- Current hypothesis is that the electrolyte degraded the adhesive layer between the battery cells and cooling channel, thereby enabling electrical conductivity from the cells through the cooling channels and the coolant fluid itself to the pack chassis.

These isolation faults were deemed to be of sufficiently high enough resistance to be deemed safe, and probably not in violation of FMVSS-305 (>500 Ohms/Volt).

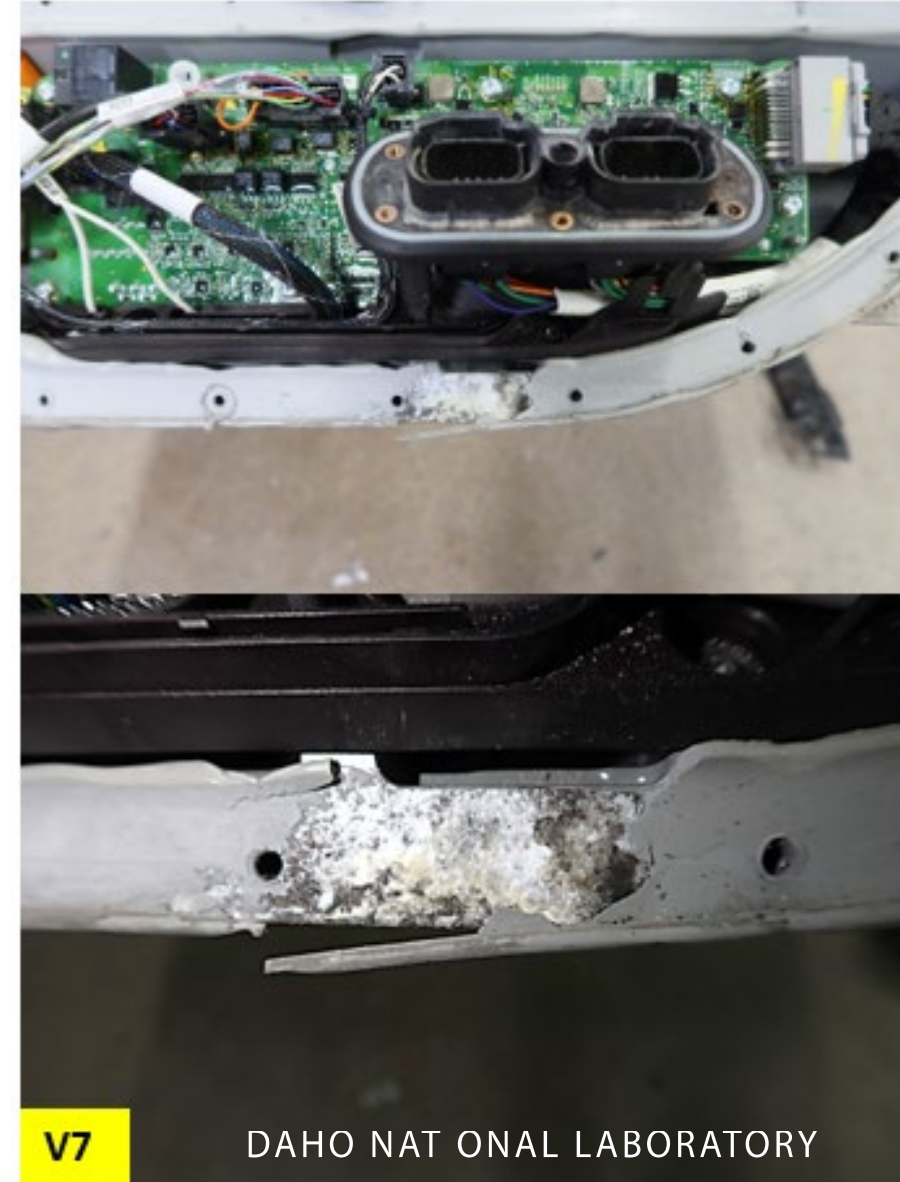
Power Distribution Unit

- Upon removal of the power distribution lid, a portion of the sealant bead remained adhered to the lid and exposed an area of corrosion on the mating surface of the tray structure.
- Although spanning the full width of the mating surface, no evidence of water intrusion or corrosion was observed on or below the power distribution components.
- It is most probable that at an undetermined point in time (most likely during the flood event) the coating of the tray structure adjacent to this sealing surface became damaged and then allowed corrosion to begin, progress, and creep under the sealant bead, eventually compromising the complete width of the sealing surface.
- Due to the lack of corrosion or contamination within the interior space, it is most likely that the corrosion progressed AFTER the flood and during storage at a vehicle scrap yard.

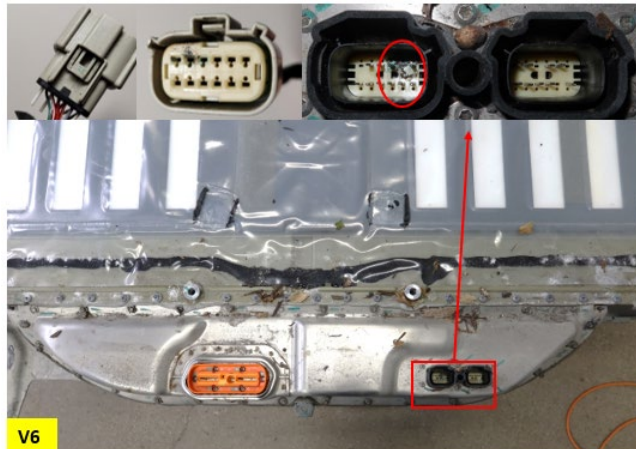
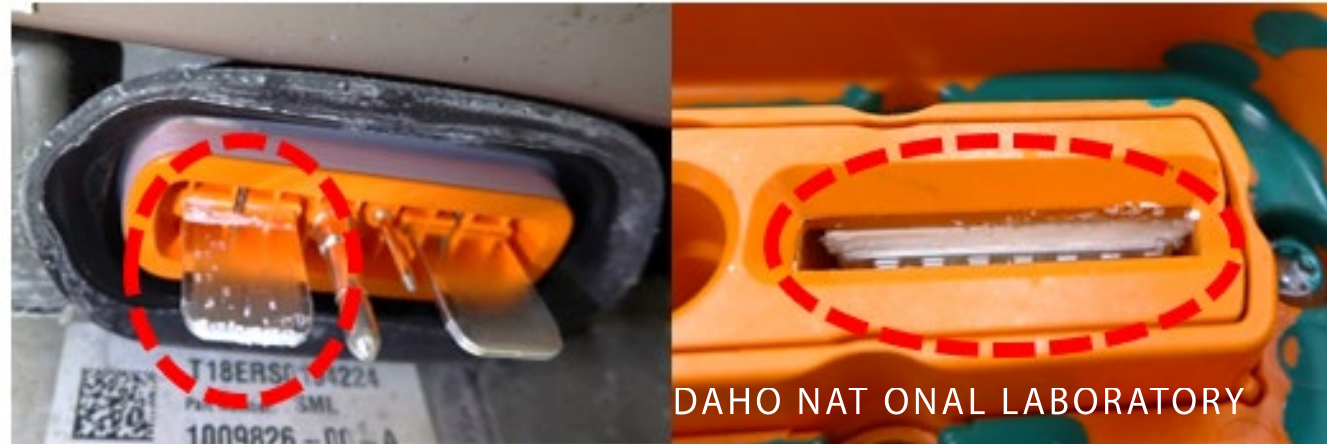
Connectors

- Upon examination of the low voltage connectors after dropping the pack, significant corrosion was noted around several pins in addition to one of the pins having been broken off in the corresponding female body-side connector:
 - The lack of a snap-fit mechanism to ensure proper installation depth of the low voltage connector is likely the mechanism by which the water was able to enter the connector and cause the observed corrosion on the pins and terminals.
- Corrosion was noted inside one of the battery pack high voltage terminals upon removal from the vehicle. The corroded terminal blade displayed white deposits around the base where it protrudes from the injection molded connector housing, suggesting that the ingress originated somewhere on the body-side high voltage harness and crept along the conductor eventually making its way into the high voltage battery connector.

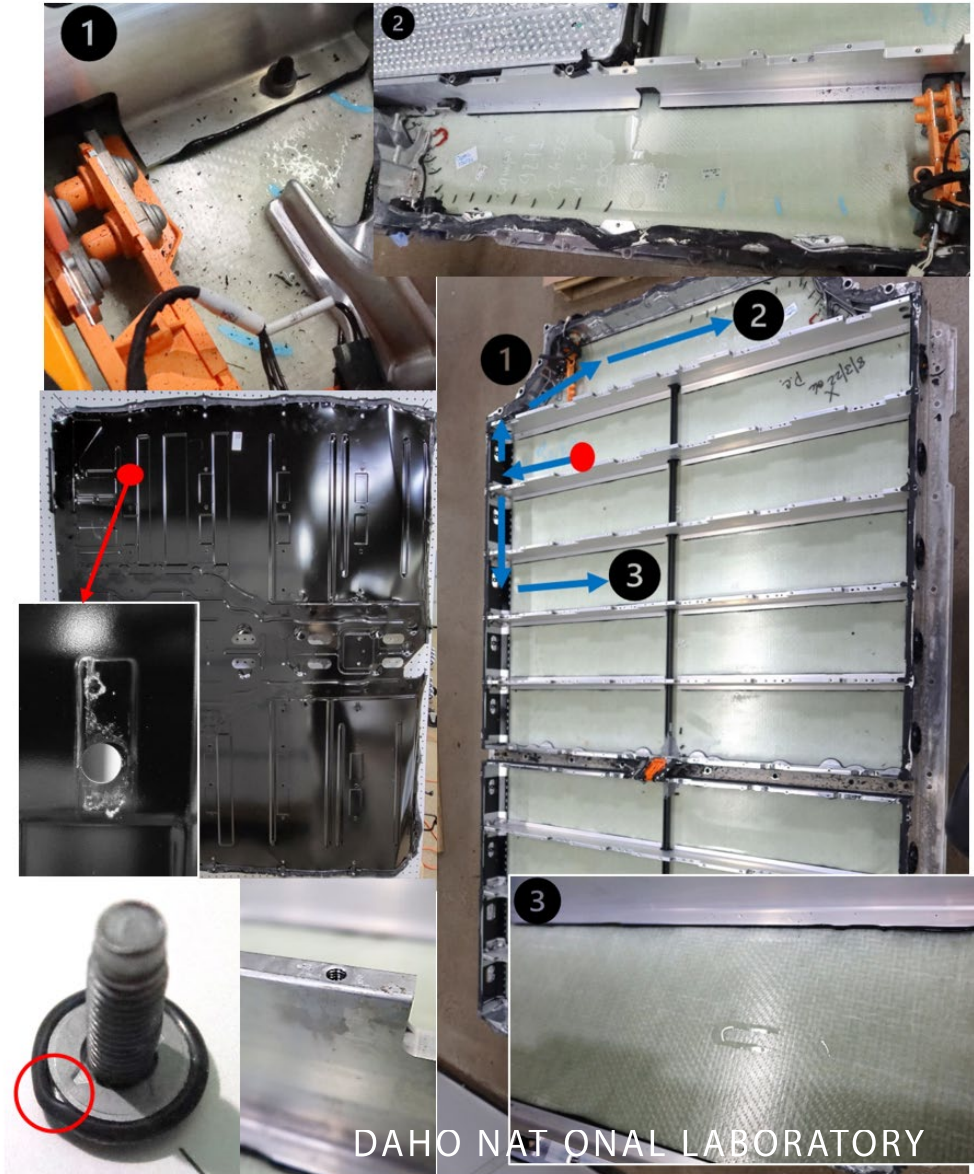
- Upon lid removal, a small amount of standing water was discovered within the front left-hand corner of the pack interior.
- Upon removing the battery modules, additional standing water was observed below two modules:

- Further inspection of the battery tray structure and components revealed no damage, corrosion, or contamination of the battery modules or electronics – however, corrosion and contamination were observed on the lid and tray cross beam around the leak source which was determined to be a compromised lid fastener seal.

- The failed lid fastener seal appears to be a manufacturing issue and not damage caused by the flooding or otherwise.
- Given that the locations of the current collectors on the bottom of the battery modules and they are covered by a polymer sheet but otherwise unsealed from the pack interior, it is reasonable to assume that they are at high risk of shorting should the level of water intrusion reach them (~1 cm).

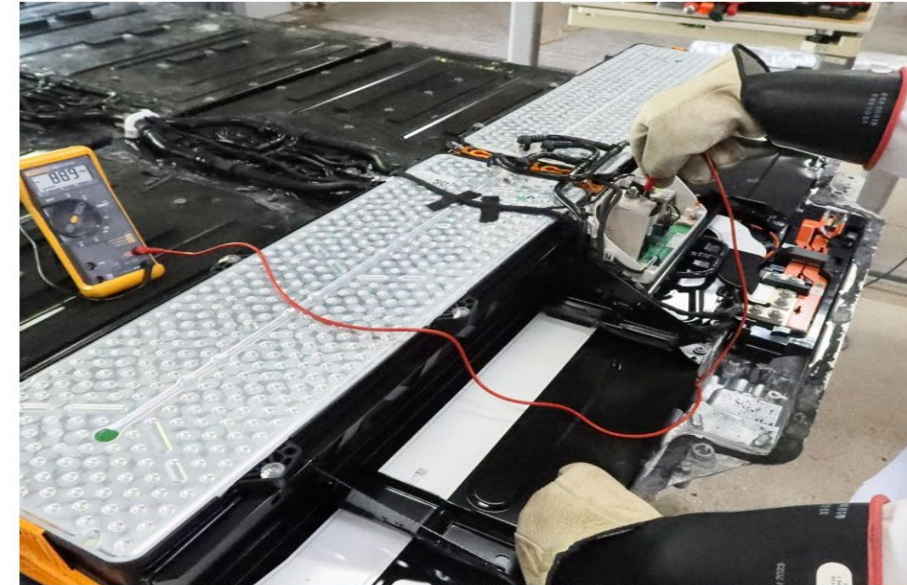
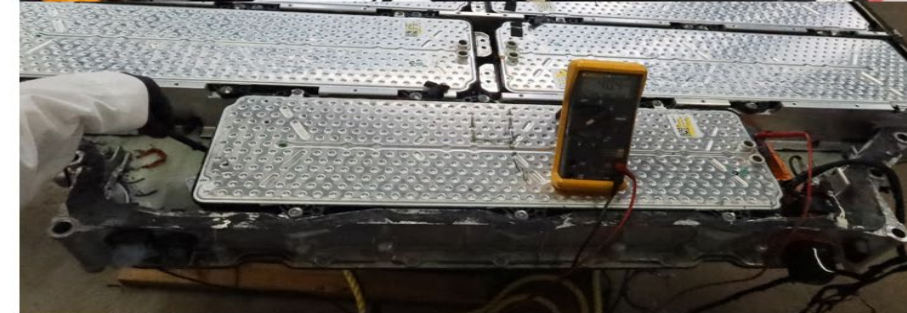
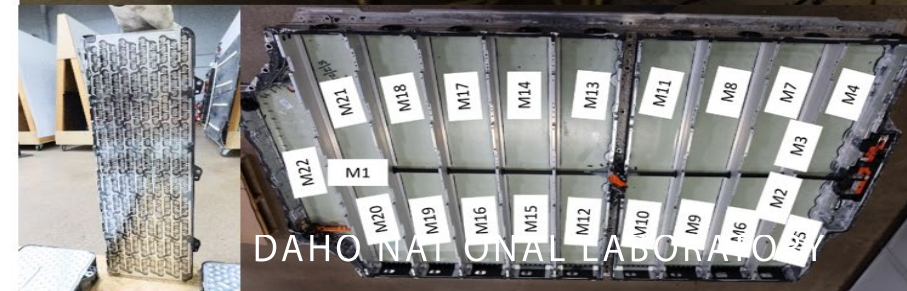
Battery Pack (cont.)

- Pack voltage was measured to be 889V, indicating a nearly full charged state (~91% SOC).
- Module-level voltages were consistent without any variation, indicating that none of the modules had shorted or otherwise been damaged by the water ingress.

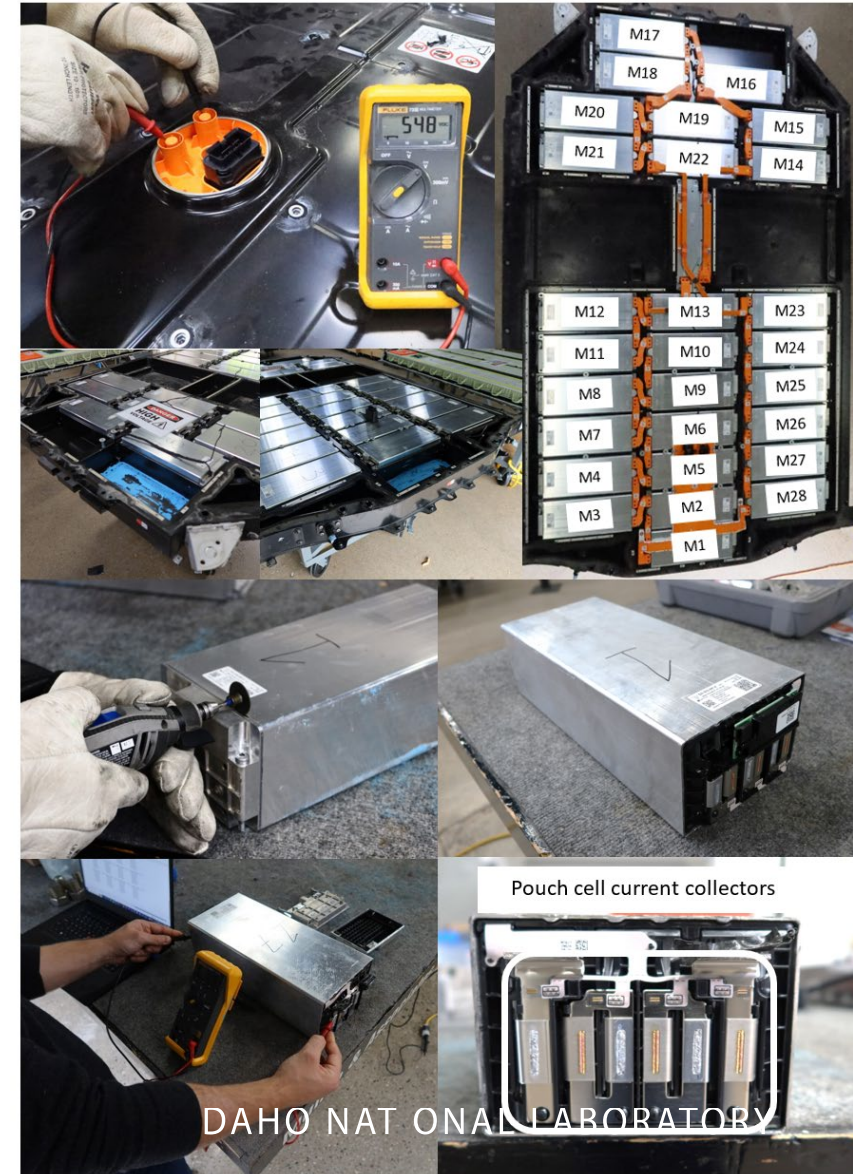
Battery Pack

- The vehicle, as received, had photo indication that it had been flooded up to the rocker panel, approximately at the floor-level of the cabin. Physical inspection of the interior and exterior of the vehicle revealed minimal debris or evidence of water, suggesting that the flood line height was insufficient to allow ingress to the cabin interior.
- Visual inspection of the exterior of the HV battery pack confirms that most of the exterior was submersed given the sediment in the second row footwell cavities in the pack, however the penthouse module on the top front of the pack showed no signs of corrosion suggesting that it remained above the flood line.

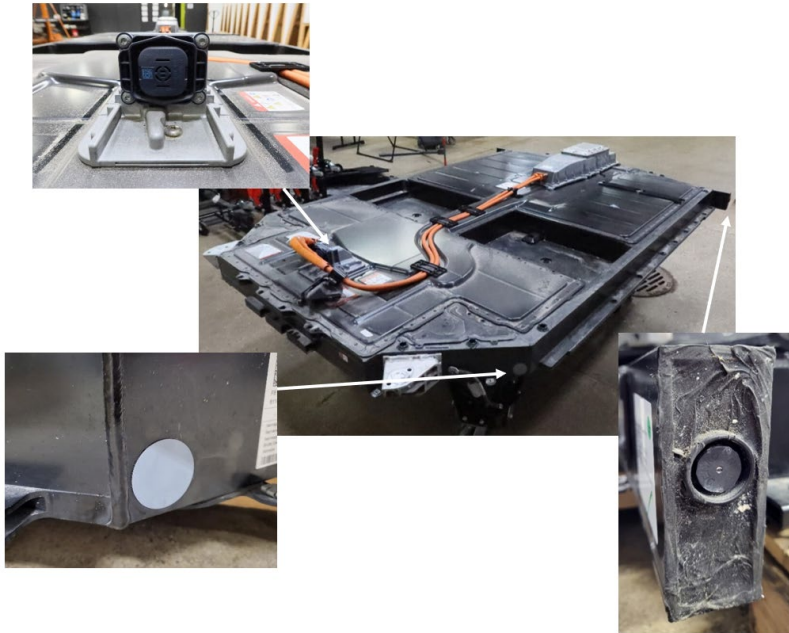
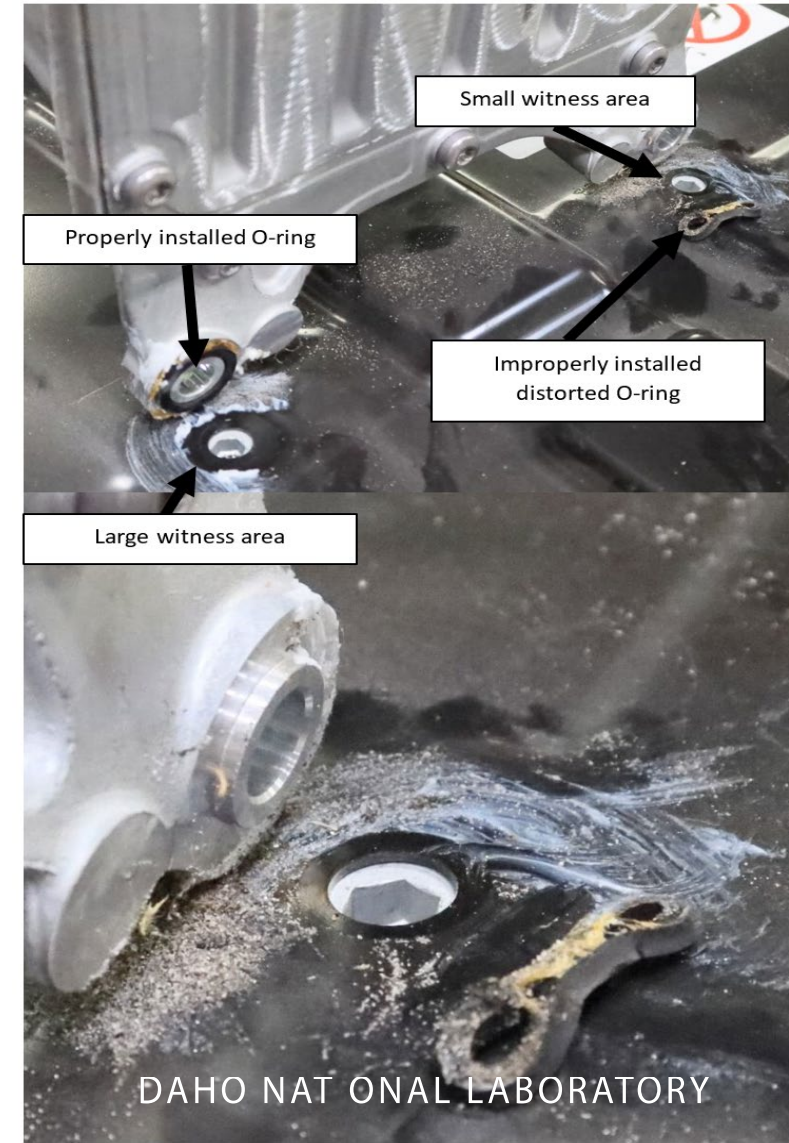
Battery Pack

- Inspection of the penthouse upon removal revealed that one of the O-rings was installed improperly, as evidenced by a displaced and crushed O-ring and a small witness area in the grease applied around the compromised O-ring:
 - Although no contamination was observed within the pack interior, it is possible that this could have become a leak path if the submersion had reached above the pack lid for an extended period.
- Vents were uncompromised.
