Tanvir Tanim, Senior R&D Scientist and Group Lead
Energy Storage Technology Group, U.S. Department of Energy
Energy Storage and Electric Transportation

A Teardown Study of Flood Damaged Electric Vehicles

EV Battery Safety, Part 2

SAE Government/Industry Meeting
January 16-18, 2024, Washington, DC, USA

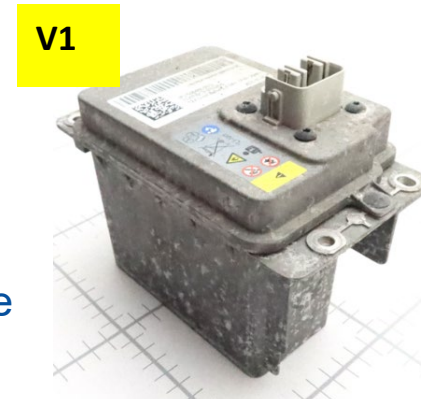
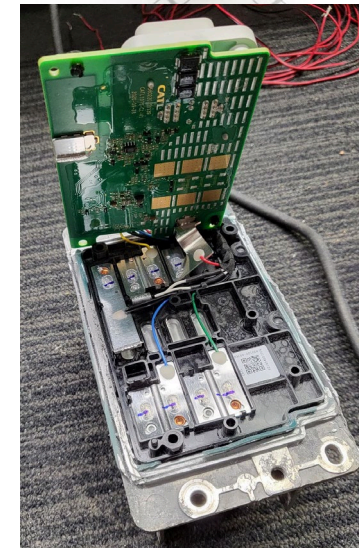
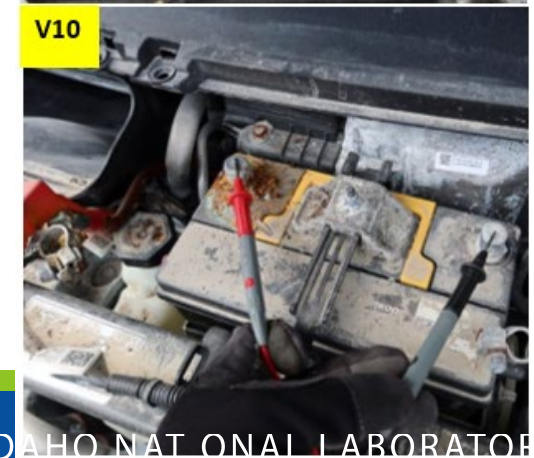
- The 12V battery for this pack design is located under the wiper cowl for this and the other pack designs of Tesla EVs.
- V1 housed a LiB, while the other vehicles had conventional lead acid battery to supply the LV power:
 - The LiB of V1 was at least partially submerged
 - The voltage reading from the main external terminals at the time of removal was 0.026V. The prismatic cell voltages were measured at 0.612V, 0.407V, 0.277V and 0.409V, or 1.7V total
 - The 12V battery interior did not display signs of water ingress suggesting that despite submersion the connector seal was uncompromised.
- Snapshots of the 12V lead acid batteries are presented, which shows evidence (marks, debris, sediment, etc.) of full submersion:
 - The terminals of all these batteries showed heavy corrosion. These low voltage batteries measured (~0.05V) to have severely drained.
