DOT HS 812 539

**Special Crash Investigations
Remote Vehicle Fire/
Child Restraint System Investigation
Vehicle: 2004 Chevrolet Silverado
Location: California
Crash Date: January 2014**

Special Crash Investigations
Remote Vehicle Fire/Child Restraint System
Investigation Case Number: DS16026
Vehicle: 2004 Chevrolet Silverado
Location: California
Incident Date: January 2014

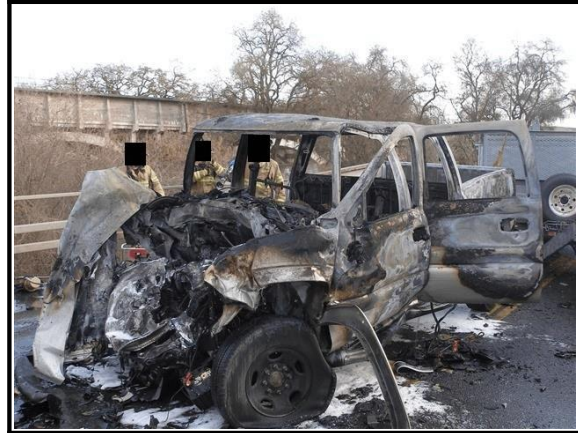
The interest of this Remote Vehicle Fire/Child Restraint System (CRS) Investigation is the post-impact fire in a 2004 Chevrolet Silverado (**Figure 1**) involved in a frontal crash with another vehicle, and the 3-year-old male occupant of the Chevrolet who was seated in a CRS in the second row. The investigation is intended to determine the events leading to the fire, how quickly the fire spread to the occupant compartment, the magnitude of the fire, how quickly EMS and other responders arrived on-scene, occupant restraint usage, demographics, injury data and CRS data. The crash was identified during a review of Fatality Analysis Reporting System (FARS) crash reports. The criteria for the crash type include a front plane impact, fire which spreads to the occupant compartment and at least one occupant seated in a CRS. The Special Crash Investigations (SCI) team obtained the police report and on-scene images for the case and it was initiated by the SCI group of the National Highway Traffic Safety Administration on December 19, 2016. Police inspected both vehicles during the investigation but did not image the event data recorder (EDR) from either vehicle.

Figure 1. 2004 Chevrolet Silverado (police image)

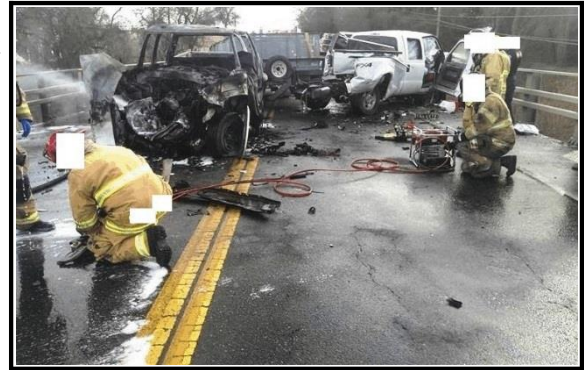
mately 180 degrees coming to rest in the northbound lane facing north (**Figure 3**). After the Chevrolet came to rest, the vehicle caught fire and soon thereafter was engulfed in flames (Event 4).

Figure 3. Final rest positions looking south, Chevrolet on left, Ford on right (police image)

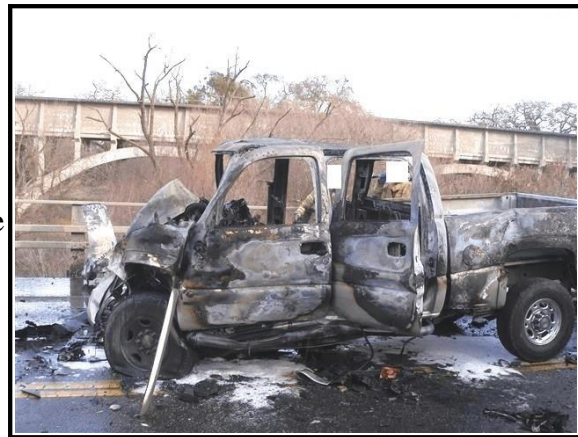
Exterior images of the Chevrolet taken by police were used to conduct a partial exterior vehicle inspection. The Chevrolet sustained direct contact damage to the front, left, right, and top planes. This damage was caused by direct contact damage during the vehicle-to-vehicle impact, and the subsequent fire and post-crash activities (**Figure 4**). The crush damage from the initial vehicle-to-vehicle event could not be separated to determine crush severity. The estimated Collision Deformation Classification for the Chevrolet in Event 1 was 11FDEW4. Thermal damage included burned paint on all planes, melted tail lamp assemblies, and melted front tires.

Figure 4. Exterior damage, 2004 Chevrolet Silverado (police image)

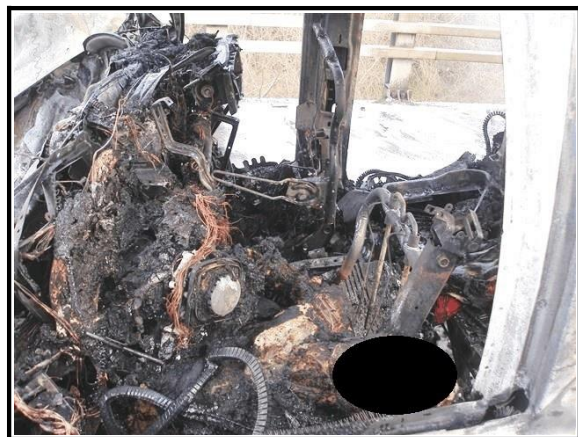
The Chevrolet sustained catastrophic interior damage caused by the post-impact fire. All side glass was disintegrated. Both rows of seats were destroyed. Few components in the occupant compartment were recognizable aside from metal framework and exposed electrical wiring (**Figure 5**).

Figure 5. Interior damage front row, 2004 Chevrolet Silverado (police image)

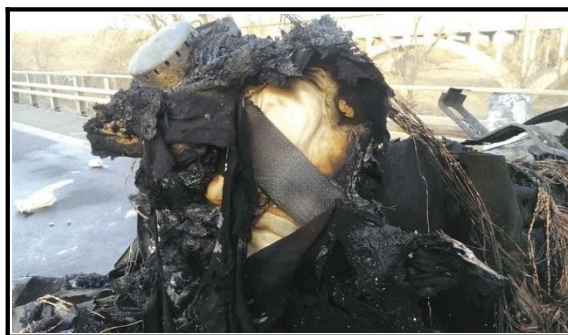
The Chevrolet's supplemental restraint systems (SRS) included frontal air bags with dual stage inflators for the front row. The driver's frontal air bag deployed at impact with the Ford. A portion of the driver's deployed frontal air bag appears in one police image to have remained intact during the fire (**Figure 6**).

Figure 6. Driver's deployed frontal air bag, 2004 Chevrolet Silverado (police image)

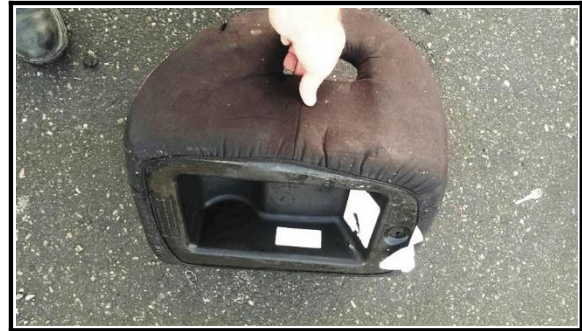
The occupant met the weight parameter (20 kg/9 lbs). It is unknown if the occupant met the height parameter. Police images show the seat to have sustained minor scuffs and dirt to the fabric seat pad. A bottom view reveals no visible damage to the shell (**Figure 8**).

Figure 8. Harmony Juvenile Cruz Youth Booster Seat, bottom view, 2004 Chevrolet Silverado

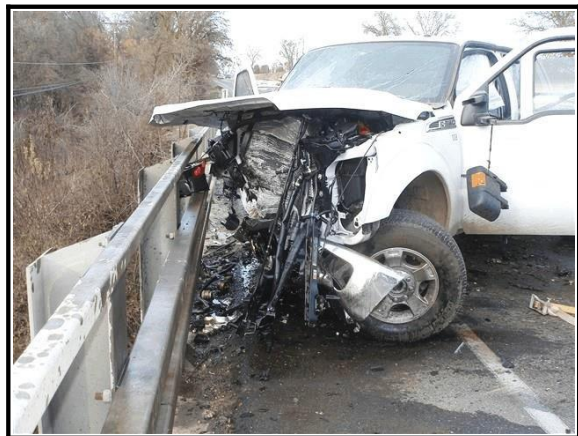
The Ford sustained direct contact damage to the front plane caused by the impact with the Chevrolet. The estimated CDC for the Ford in Event 1 was 12FDEW4 (**Figure 9**). It also sustained direct contact damage to the left plane caused by intra-unit contact with the trailer during the crash (**Figure 10**). There was a secondary impact with the metal bridge railing following the initial impact.

Figure 9. Front end damage, 2014 Ford F-250 (police image)

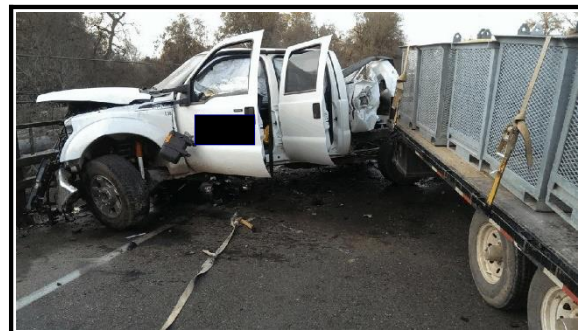
Figure 10. Intra-unit damage, 2014 Ford F250
