# Update on Lower Interior Impacts to Seat Backs and B-pillars

*Kedryn Wietholter, NHTSA*

*SAE Government Industry Meeting | April 3-5, 2019*

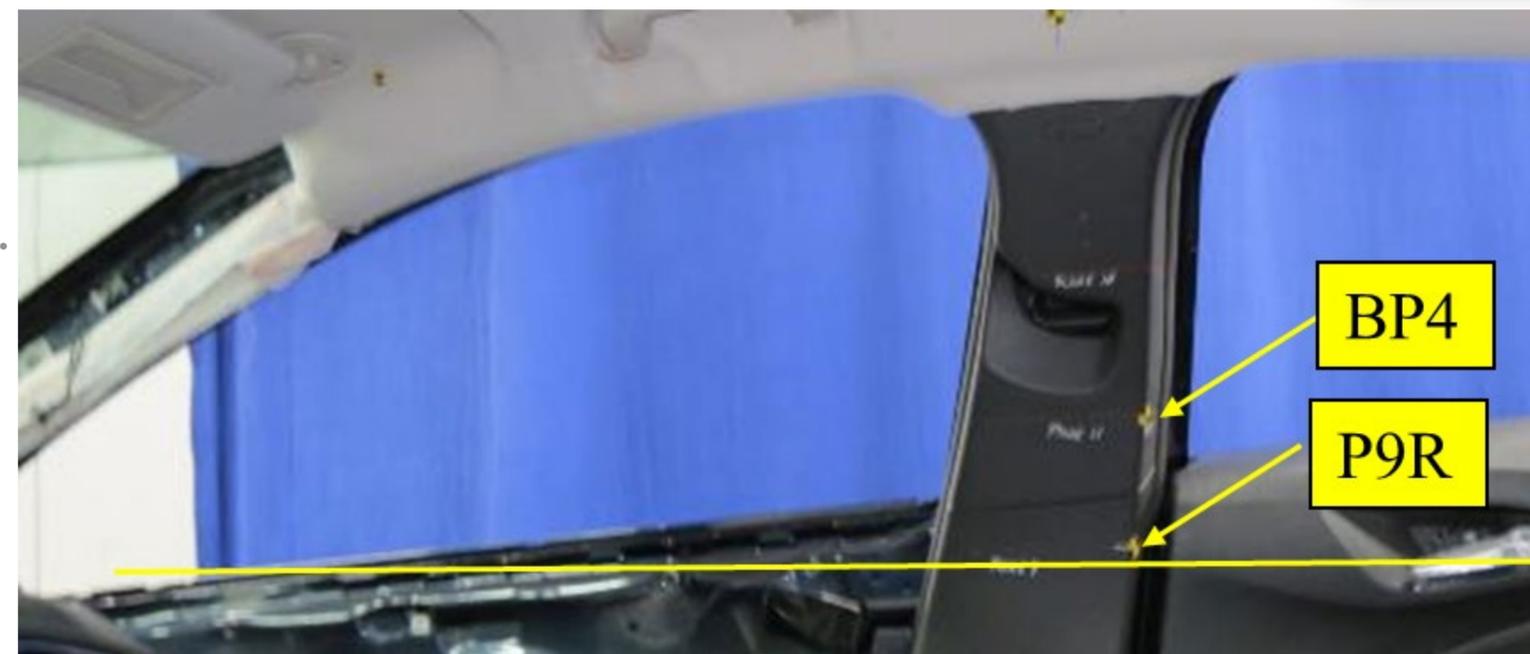
## B-pillar

1. BP4 from FMVSS No. 201 for comparison
2. Plane 9 – Rear Edge (P9R)

- 201HF and APHF
- Test lower B-pillars at BP4 (for comparison) and at rear edge windowsill plane at 15 mph
- Test seat backs at four impact locations: three impact locations on seat back and one on head restraint at 20 and 25 mph

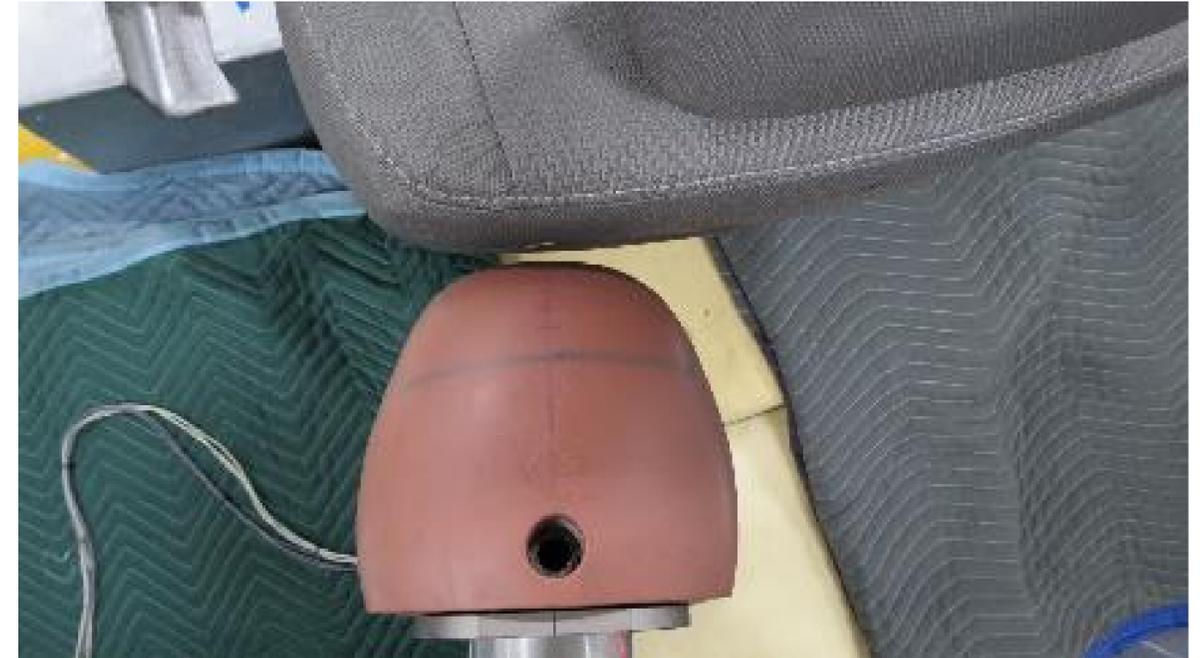
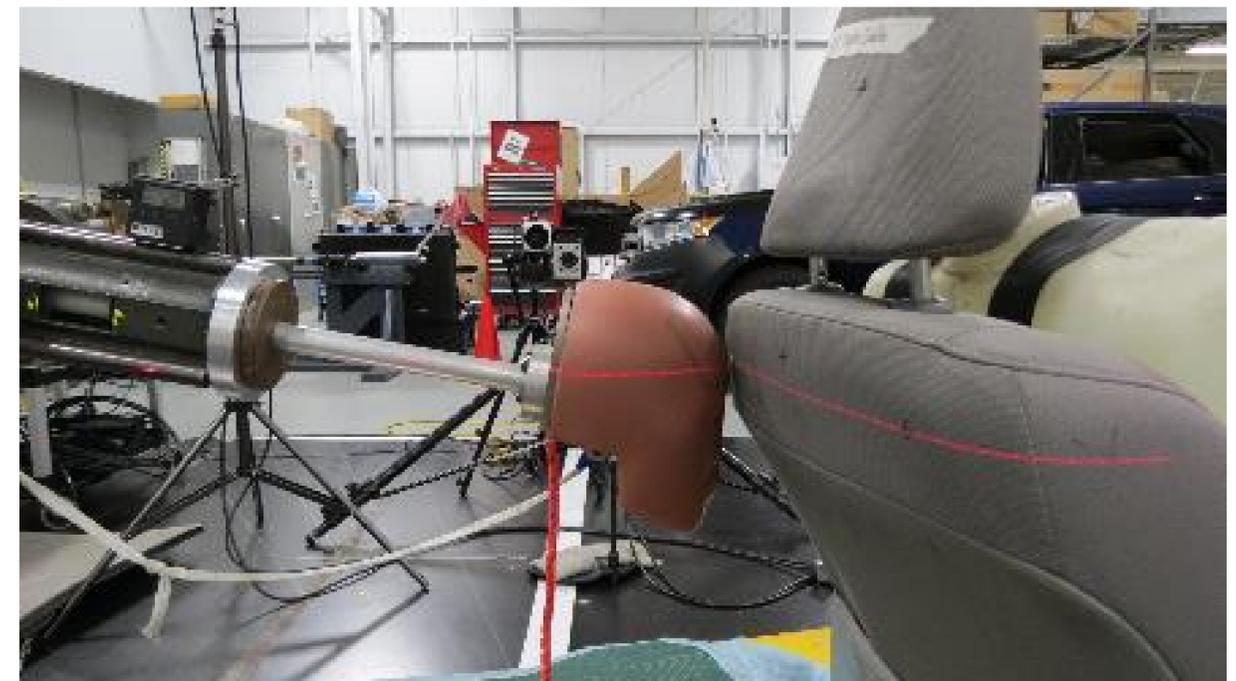
# Test Procedures: Seat Backs

- FMVSS No. 201 test procedure states “the launching angle should represent the most severe test condition”
- Testing was completed at various horizontal and vertical approach angles
  - As direct hit as possible to eliminate glancing blows
- SAE J826 OSCAR used to set seat angle to 25 degrees
- 175 lb water dummy to hold seat back in position

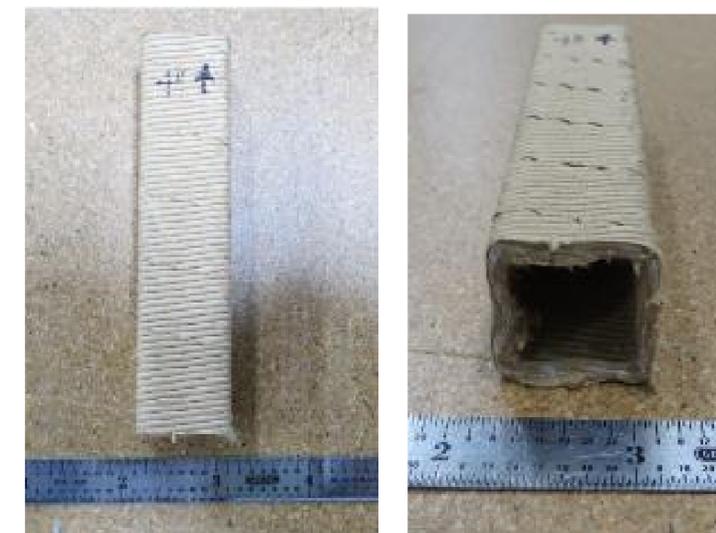
**O-Flex Tubing**  
Energy absorbing tube  
Various aluminum foil thickness and  
compositions  
Tested 23-56 mm thickness

- Objective: To find a countermeasure that lowers HIC36 to less than 800 for each impact location
- Component Database<sup>2</sup> Nos. C01606-C01697
- Lower B-pillar (15 mph)
  - 2016 Chevrolet Malibu, 2016 Ford F-150, and 2016 Nissan Rogue
- Seat Back/Head Restraint (25 mph)
  - 2016 Chevrolet Cruze, 2016 Ford F-150, and 2016 Nissan Rogue
- Repeated tests at angles from test matrix with added countermeasures

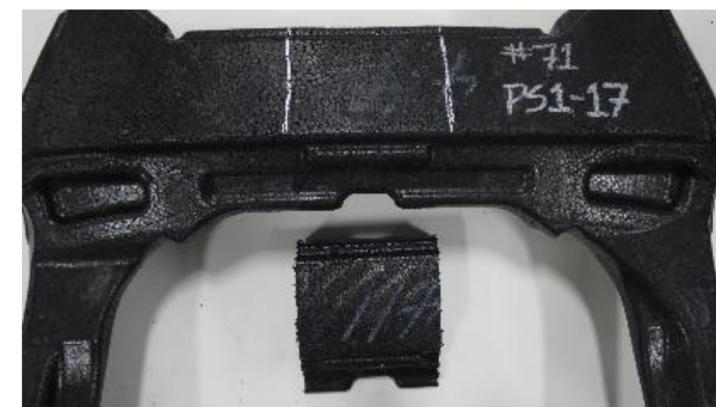
**Jeep Grand Cherokee Seat Back Foam Bezel**  
Expanded Polypropylene (EPP) Foam  
Tested 35-38 mm thickness
