Special Crash Investigations Program: Investigation of a Fatal Crash Involving a Vehicle with Level 2 Automation

SAE Government Industry Meeting
January 24-26, 2018

Harold Herrera
Crash Investigation Division
Special Crash Investigations

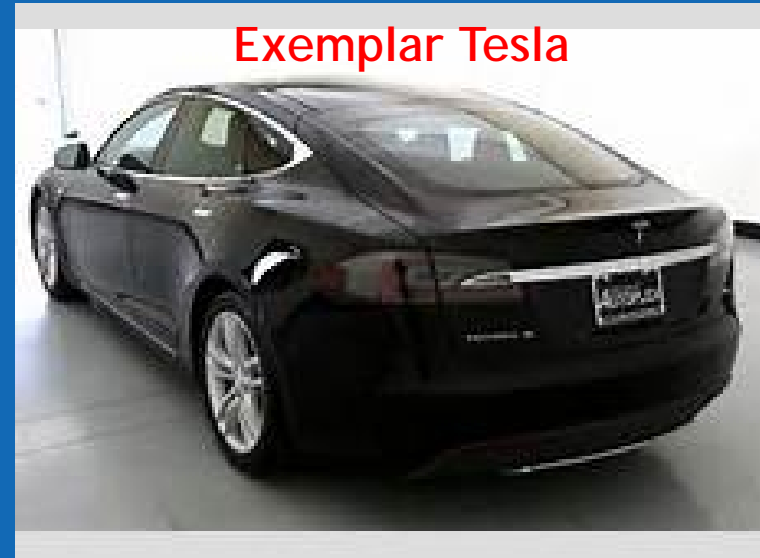
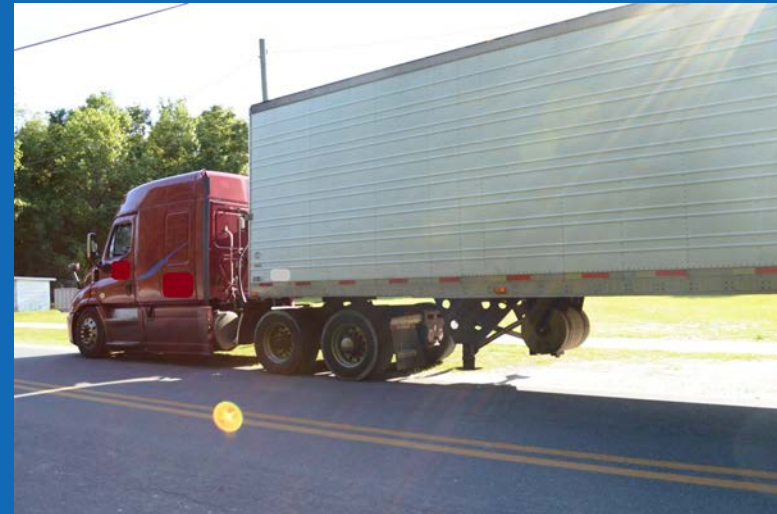
- Crash in May 2016 in Florida
 - 2015 Tesla Model S 70-D
 - 2014 Freightliner Cascadia tractor\power unit
 - 2003 Utility Trailer unit

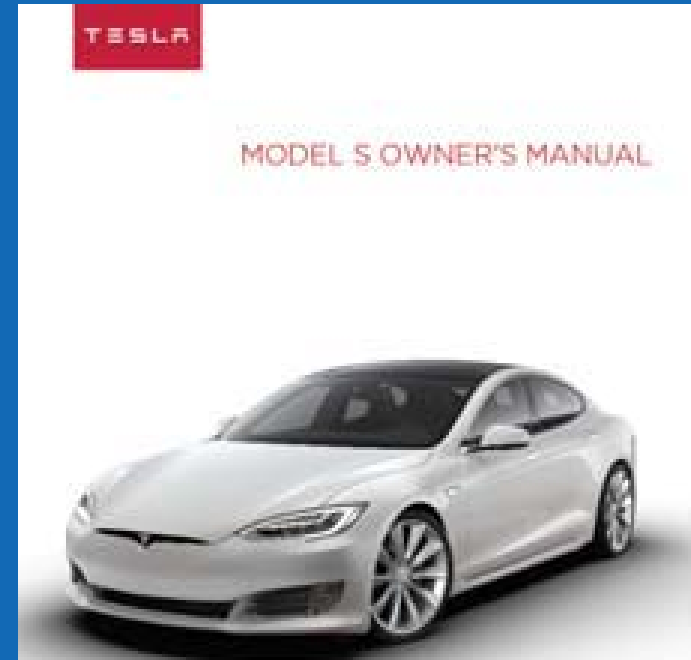
- Autopilot was made incrementally available to this vehicle through software upgrades
 - *Autopilot allows Model S to steer within a lane, change lanes with the simple tap of a turn signal, and manage speed by using active, traffic-aware cruise control. Digital control of motors, brakes, and steering helps avoid collisions from the front and sides, as well as preventing the car from wandering off the road*
- Designed for limited access highways with prominent lane markings
- Technology was not intended to replace human driver

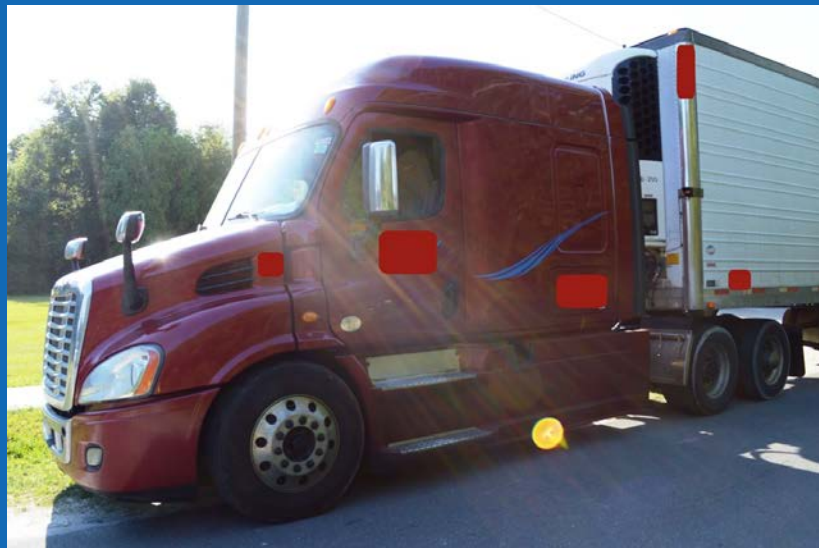
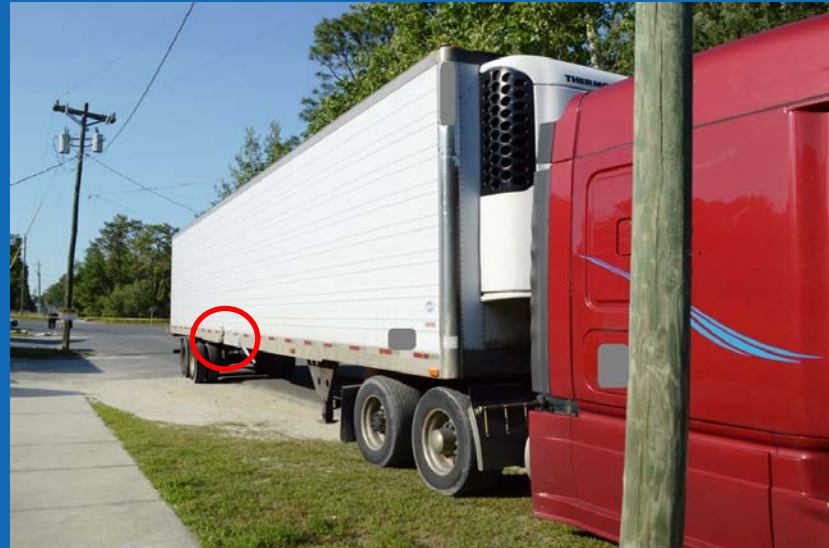
- 2014 Freightliner Cascadia tractor
- 2003 UTI dual axle refrigerated 53' box trailer
- Trailer had a GVWR of 65,000 lbs
 - Loaded with 16 pallets of produce that weighed approximately 20,000 lbs

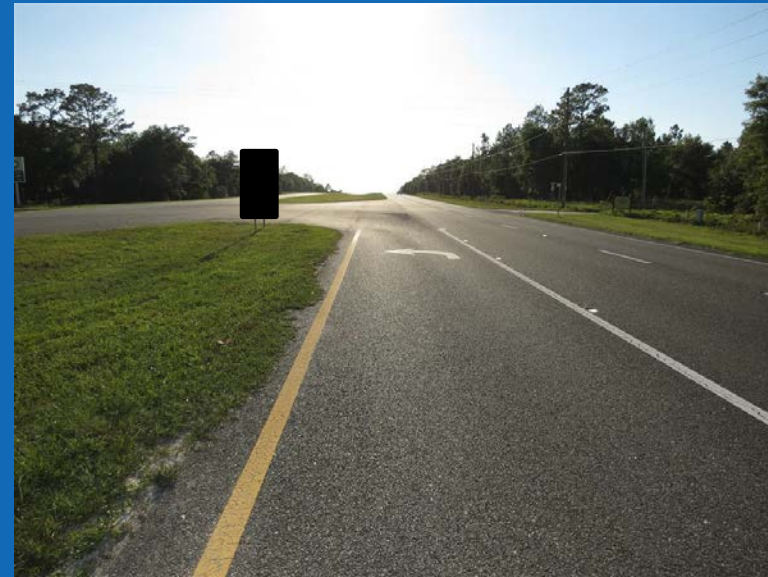
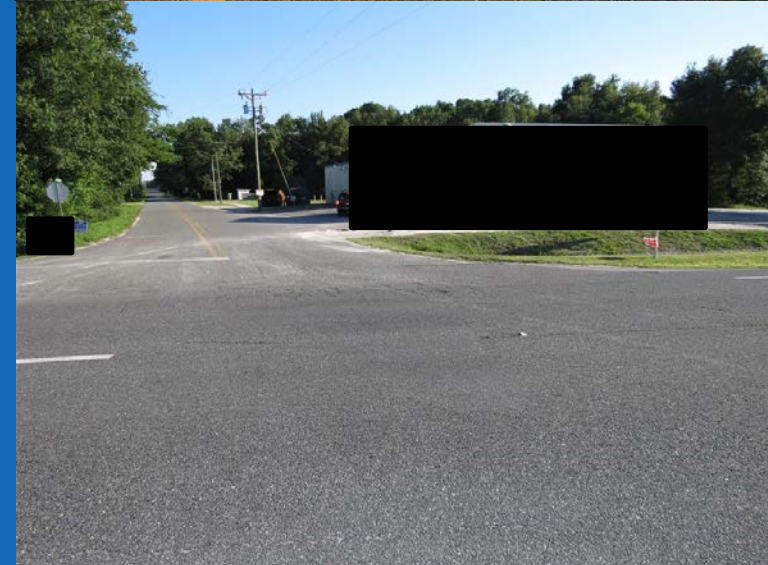
- Other vehicle (Freightliner) operated by 62-y/o driver
- Freightliner initiated left turn across the path of the Tesla
- Impact was in right lane, traveled approximately 72 ft through the turn
- Did not make statement to police
- Initially indicated to SCI:
 - “Did not see” the Tesla
- During 2nd interview indicated:
 - Came to a full stop prior to left turn
 - No vehicles were within his sight, began left turn
 - During acceleration he noticed Tesla crested transition to 2.5% downgrade
 - Thought he had enough time to complete turn

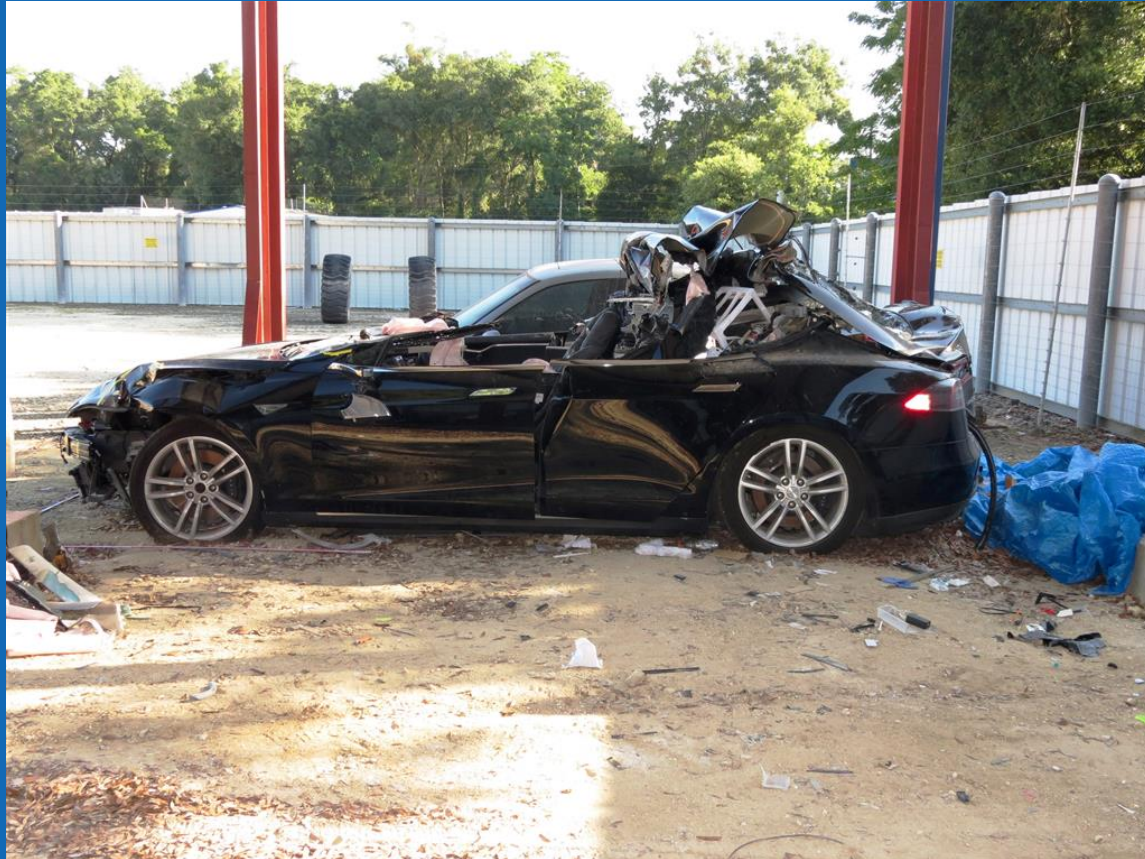
- Tesla under-rode trailer at the mid point area
- Sheared the greenhouse and roof structure from Tesla
- Driver's head contacted numerous intruding components
 - sustained fatal injuries

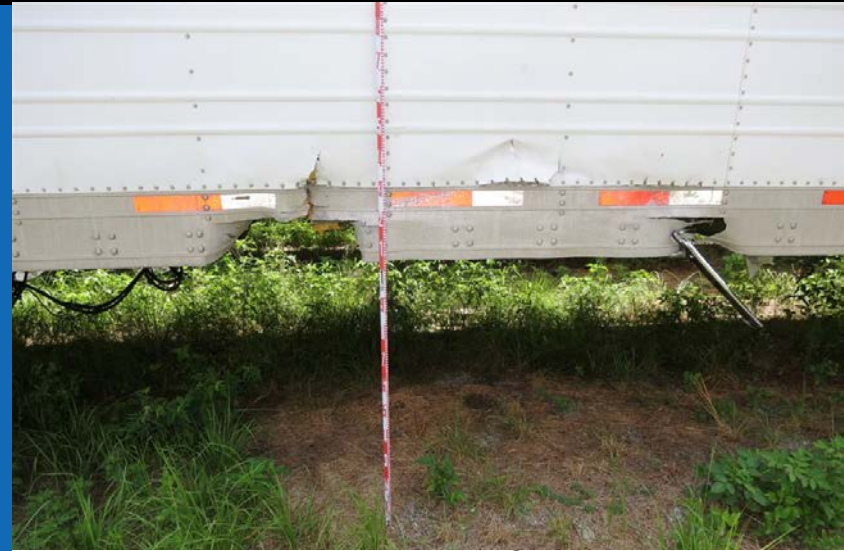
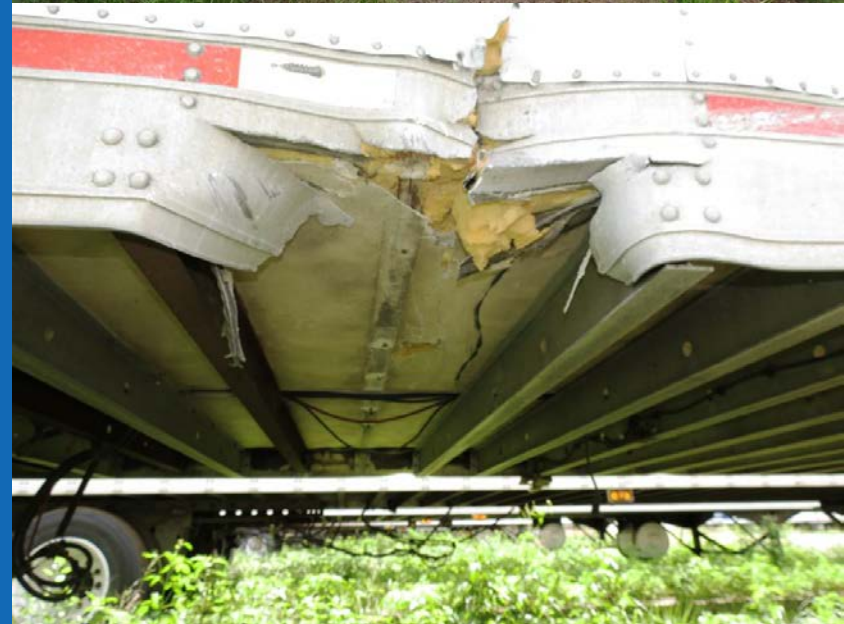
- Right side of trailer impacted
- Damage evident across underside of trailer

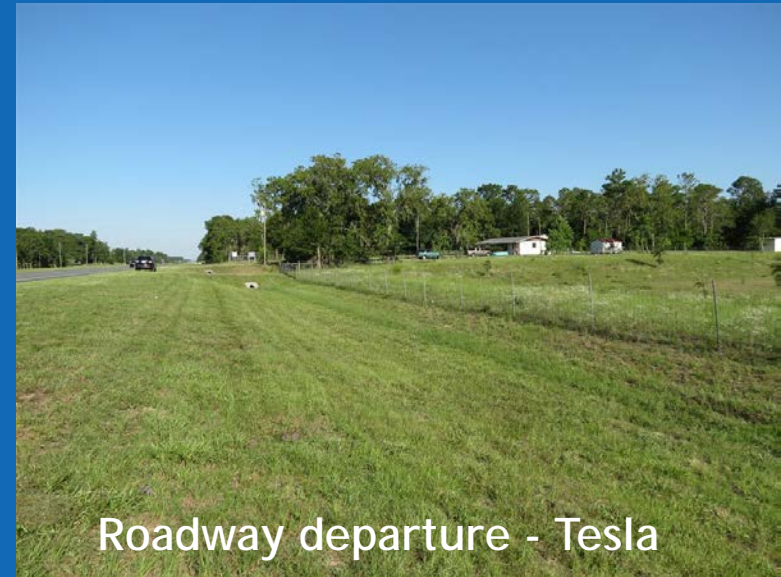
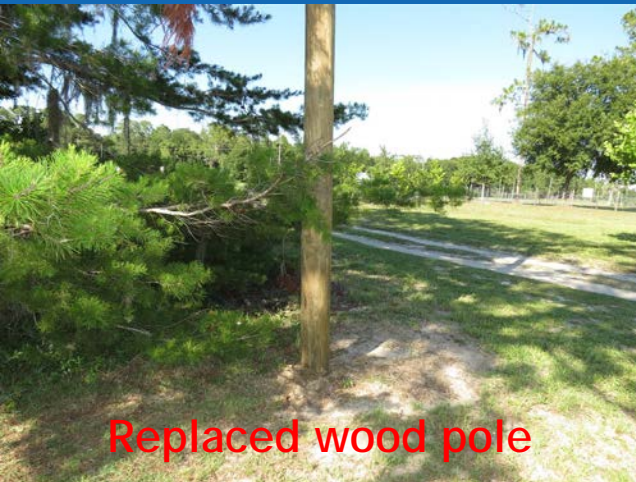
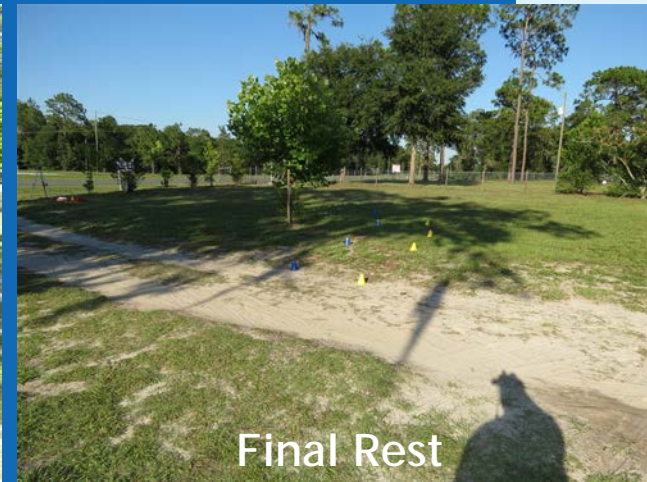
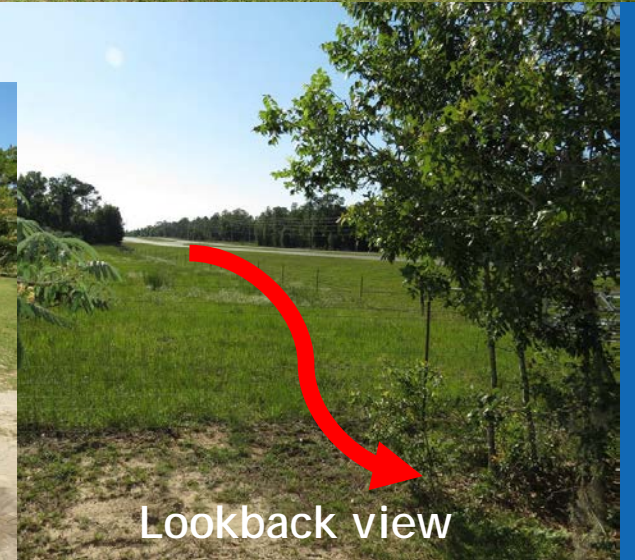
- Tesla continued ESE path off road and contacted
 - Chain link Fence 2x
 - Wooden utility pole
 - Then rotated CCW to final rest

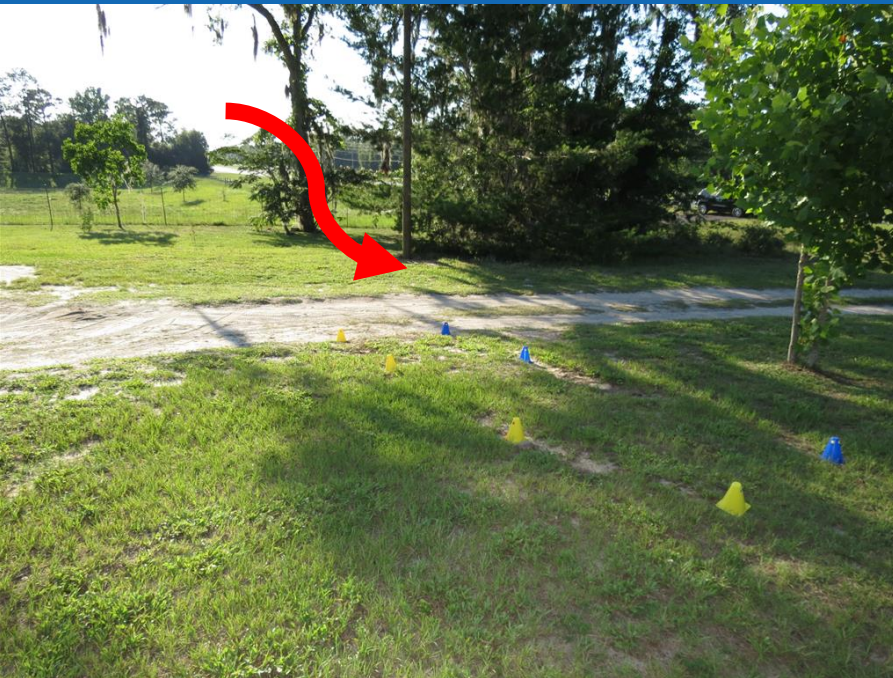
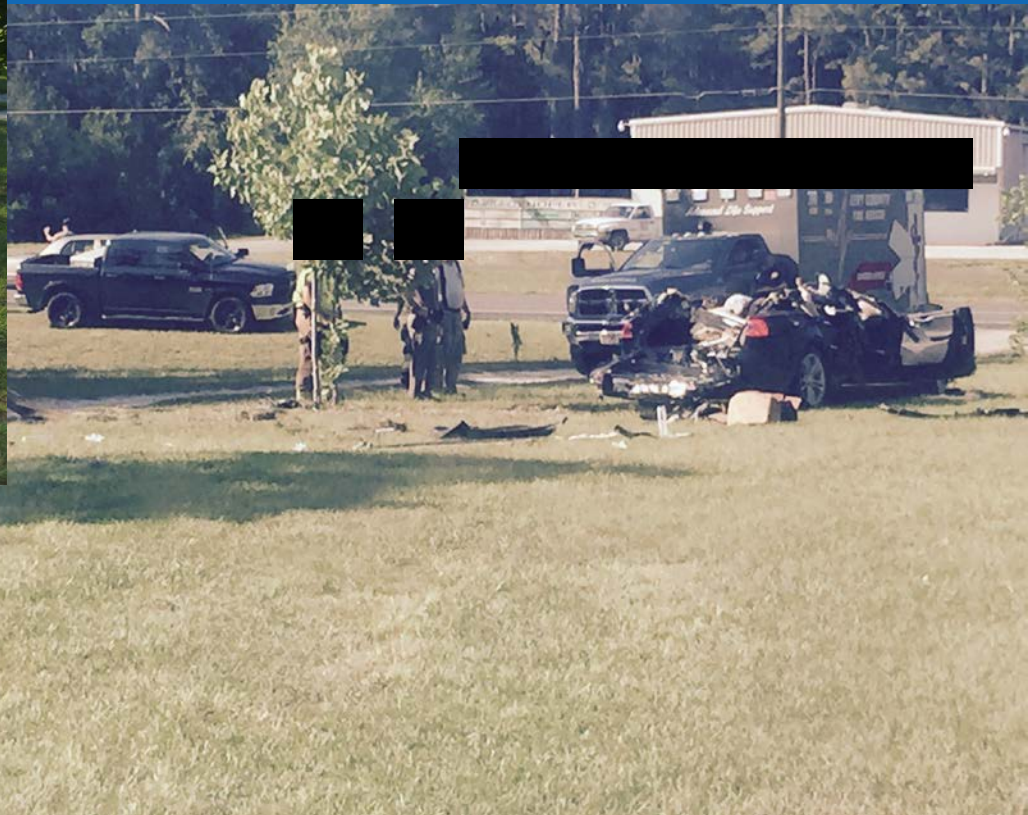
- Trajectory ~886.5 ft from impact with tractor-trailer to final rest of Tesla

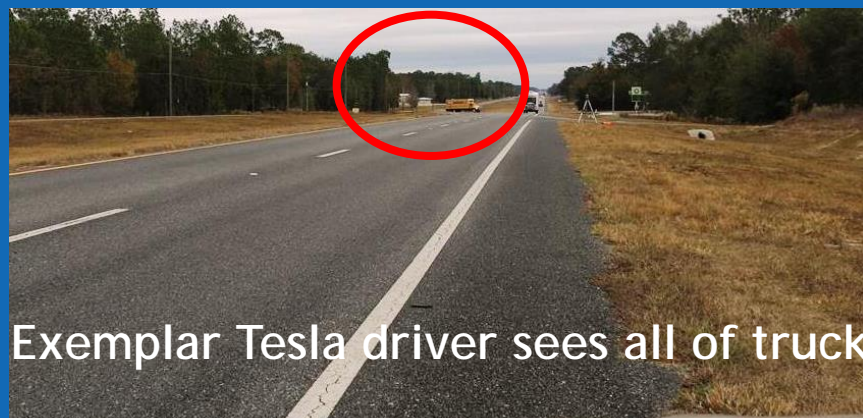
- Exemplar vehicles (approximating eye height) were used to establish line of sight
- Line of sight measurements were taken with the Freightliner at “reported” stopped position and as moving through turn
- Exemplar driver (Tesla) begins to see top of truck at 1,417 ft
- Exemplar driver sees all of truck at 961 ft
- 2 ft traffic cone placed on eastbound lane near POI
 - Visible to exemplar driver at ~1,073 ft

Exemplar Tesla driver sees all of truck

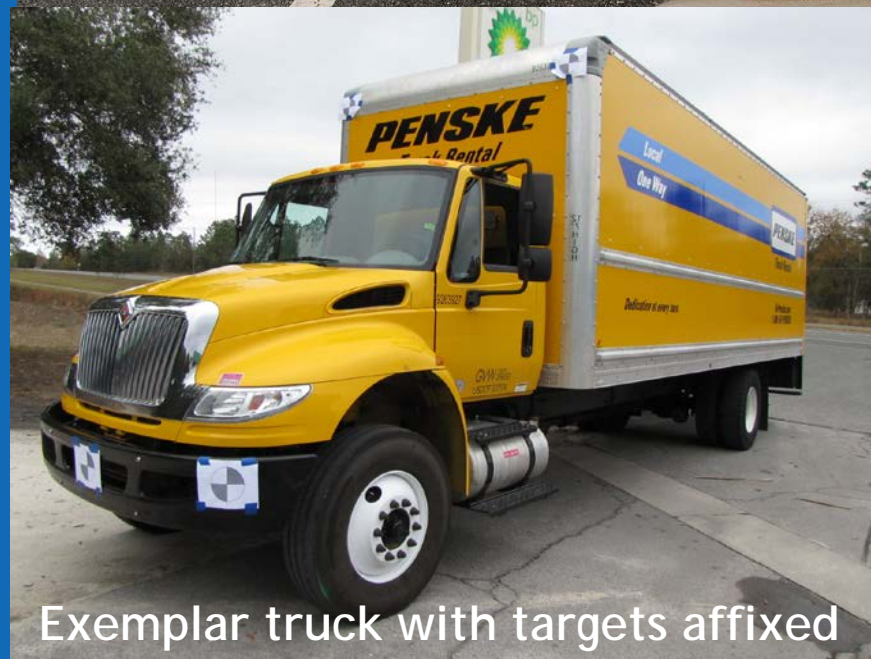
Exemplar truck with targets affixed

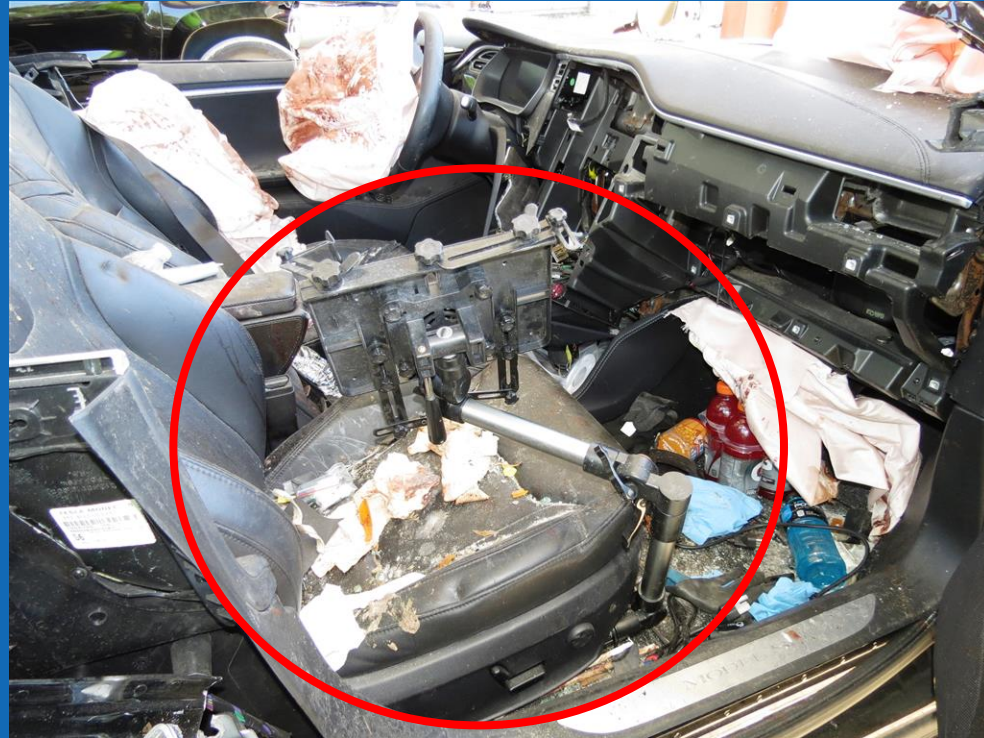
- Additional equipment present:
 - Laptop computer
 - Monitor
 - Cell phone
- Aftermarket Computer Mounting system
 - Attached to right front seat
 - All attachments loose so pre-crash position was undermined
