Hand Control Usage and Safety Assessment

Final Report
August 2001

**U.S. Department of Transportation Volpe
Transportation Systems Center**

**Automobile Safety Laboratory
University of Virginia**

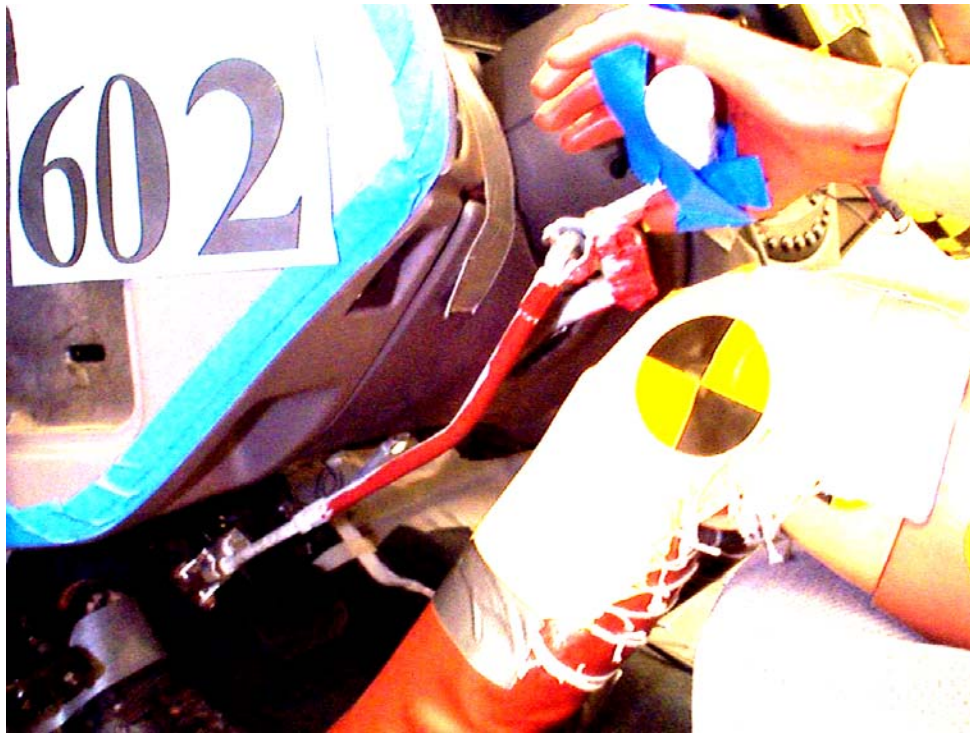
Tests 600-605 were conducted to investigate the crash safety of commonly used hand controls. The tests included an initial baseline test conducted without a hand control (Table 1). Hand controls are devices used by people who are unable to operate the brake and accelerator pedals due to physical impairment. Hand controls typically are rod linkages attached at the lower end to the brake and accelerator pedals. The rods are supported by a bracket mounted underneath the steering column and terminate in a single handle positioned near the perimeter of the steering wheel. Pushing this handle pushes the brake pedal. Moving this handle back or down, or twisting the handle pushes the accelerator pedal (Fig. 1).

Figure 1. Typical hand control installation. MPS Monarch hand control pre-test 602.

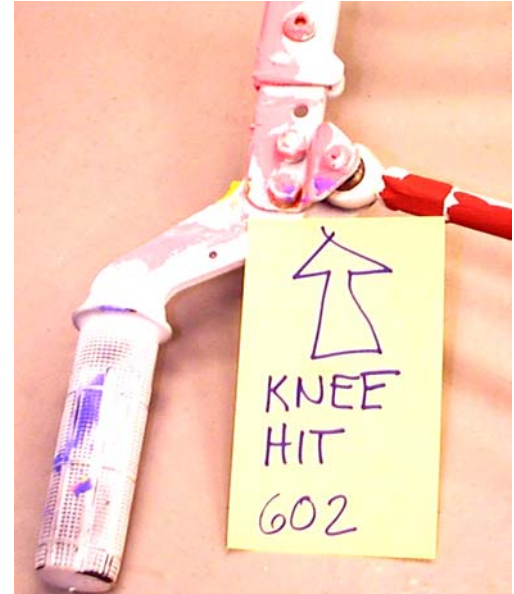
Figure 6. Edge of nut that caused knee cut on the underside of the hand control.

Figure 5. Knee cut in test 602 indicated by arrow.
