# GOVERNMENT/INDUSTRY MEETING

## Thoracic and pelvic responses and injuries to post-mortem human subjects (PMHS) in rear-facing seat configurations in high-speed frontal impacts

<sup>1</sup>Injury Biomechanics Research Center, The Ohio State University

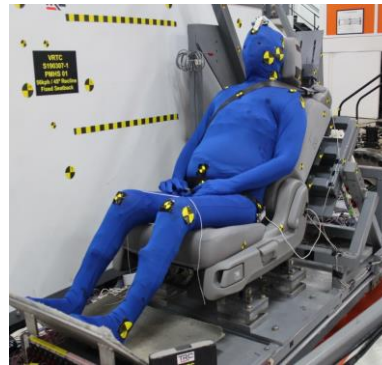
- Recent rear-facing studies [Kang et al., 2020 & 2022]
  - PMHS responses and injuries at  $\Delta V$  of 56km/h
  - Two recline conditions (25deg & 45deg)
  - Original equipment manufacture (OEM) seats with rigid reinforcement
    - ABTS (Kang et al., 2020)
    - FDR (Kang et al., 2022)
- PMHS injuries
  - Cervical spine laxity
  - Upper extremity injuries
  - Lower extremity injuries
  - **Rib fractures**
  - **Pelvis fractures**

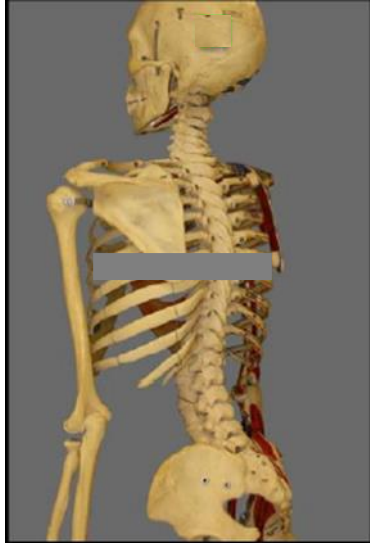
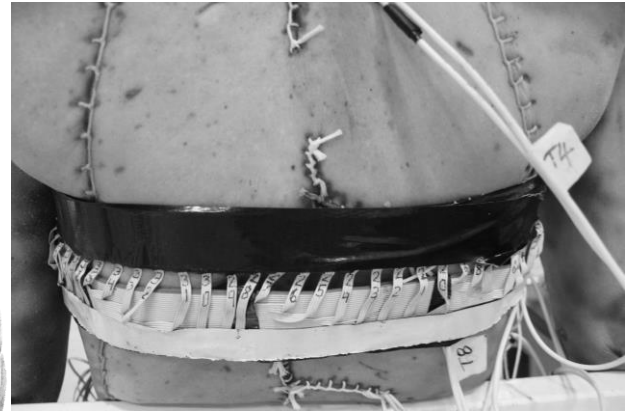
# PMHS Instrumentation – Chest Band

- Chestband
- Strain Gauges

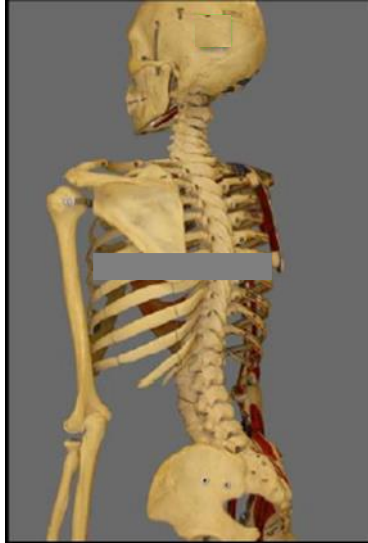
# PMHS Instrumentation – Rib Strain Gage

Anterior: rib 3-9  
Posterior: rib 3-10

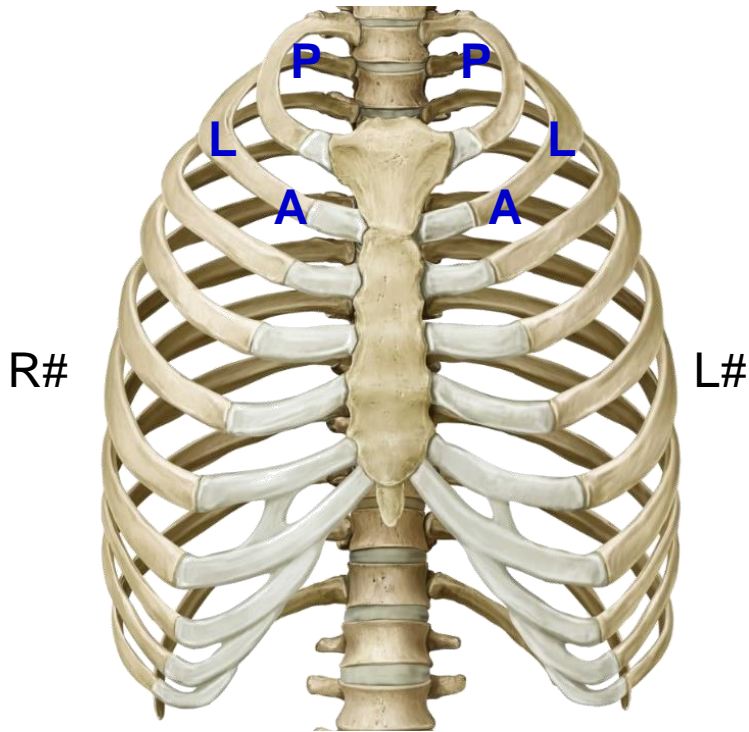
# Rib Fracture Location and Frequency

: no fractures  
 : one PMHS  
 : two PMHS

: three PMHS

- Difference in fracture distribution between ABTS and FDR
  - More rib fractures in 45deg condition
  - Anterior and lateral fractures occurred due to chest inertial loads
  - Seatback properties and structure design influenced fracture locations
- Rib fractures after maximum chest deflection and seat load
  - Thorax may experience complex combined loadings, especially in the 45deg recline condition
    - Compression due to A-P inertial loading
    - Shear due to ramping up motion

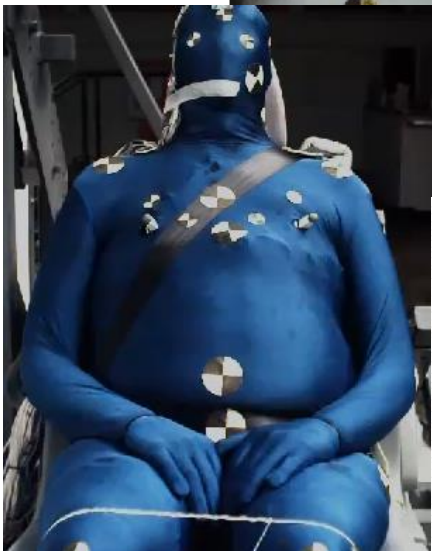
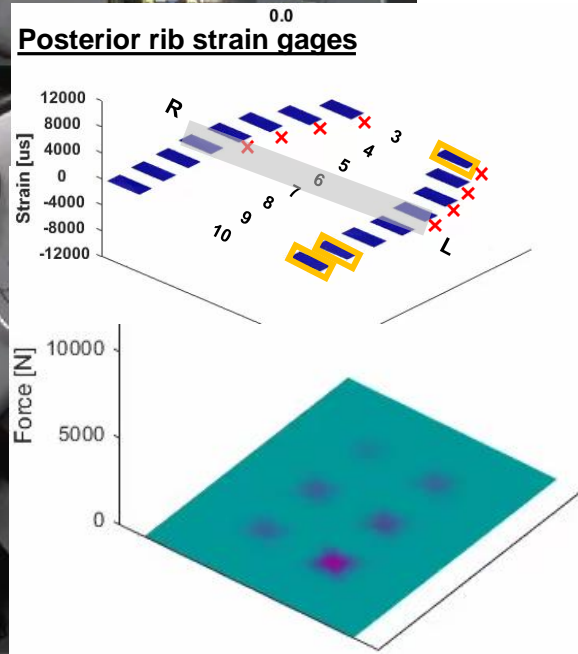
# ABTS 45deg at 56 km/h

✗ Fracture  
☐ Broken gage

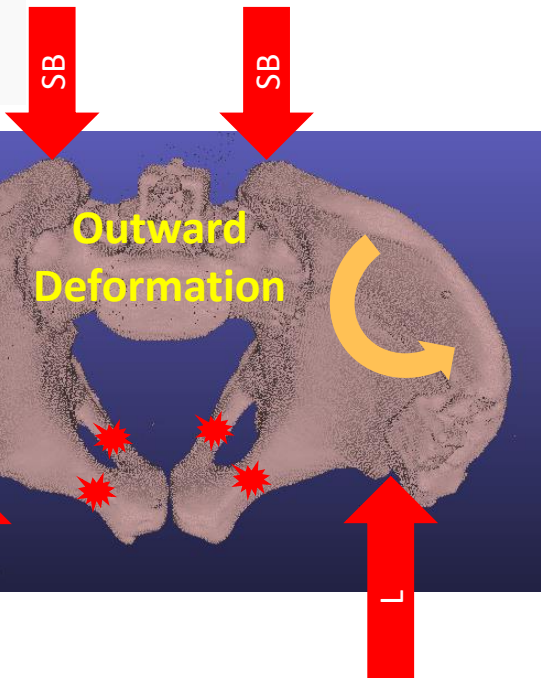
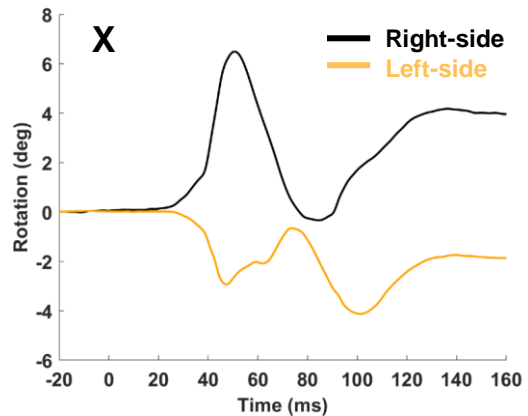
25 deg & 56km/h in FDR

**Outward deformation: explained by off-axis rotations  
→ may be an indicator of fractures**

- Off-axis rotations from both iliac wings represent pelvis outward deformation
  - Maybe an indicator of the pubic ramus fractures

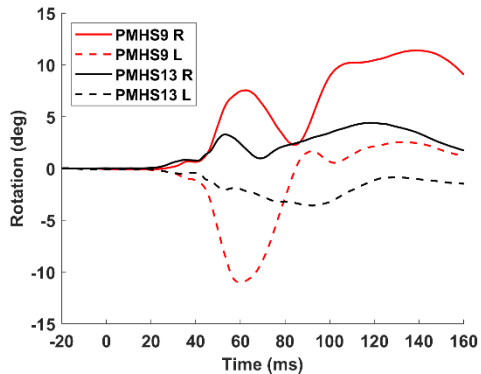
FDR 45deg

PMHS9:  
bilateral fxs

Rotation about X-axis

Rotation about Z-axis
