DOT HS 812 535

Special Crash Investigations On-Site Rollover Investigation Vehicle: 2015 Chevrolet Cruze Location: California Crash Date: December 2015

**On-Site Rollover Investigation
Case Number DS16005
Vehicle: 2015 Chevrolet Cruze
Location: California
Crash Date: December 2015**

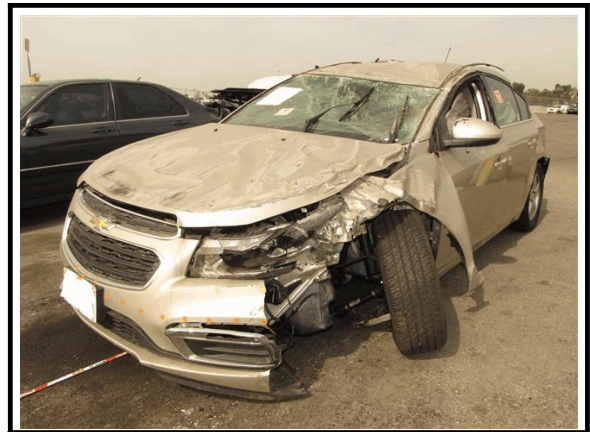
Figure 1. 2015 Chevrolet Cruze

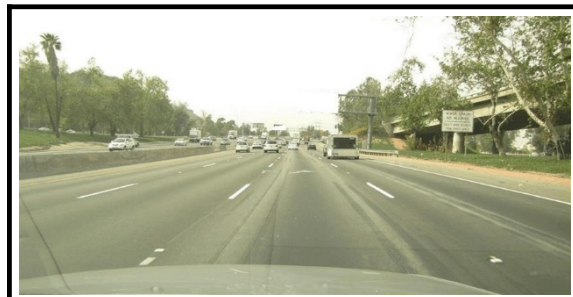
The crash occurred on a four-lane, northbound interstate highway in California (**Figure 2**). The roadway was concrete-surfaced and was configured with paved shoulders measuring 1.2 m (4.0 ft) on the left edge and 3.0 m (10.0 ft) in width on the right edge. The lanes were separated by dashed white painted stripes and the roadway was bordered by a solid yellow painted stripe on the left edge and a solid white painted fog line on the right edge. This roadway was straight and level, and the posted speed limit was 105 km/h (65 mph) for two-axle vehicles and 89 km/h (55 mph) for heavy trucks. The investigating police officer noted no unusual conditions present at the time of the crash. The vehicles were moved prior to police investigation and final rest positions of the vehicles was unknown.

Figure 2. Crash site, northbound approach view

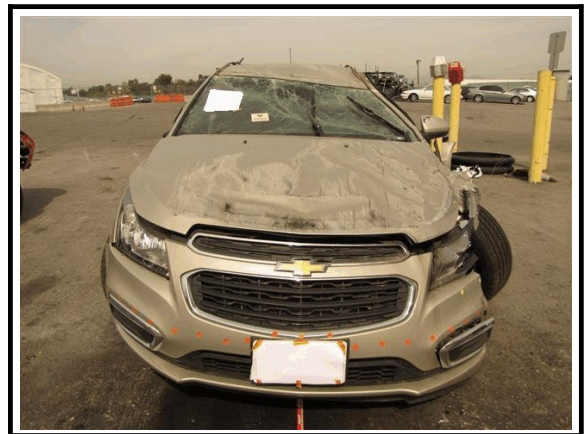
The Chevrolet sustained moderate severity crush damage to the front plane caused during the impact with the Mack and moderate severity crush damage to the roof caused during the rollover. For the frontal impact, the damage was located on the front bumper fascia, front left headlamp, left front fender and left front tire/wheel assembly. The left front tire was restricted. Direct damage to the bumper fascia began at the front left bumper corner and extended 17.0 cm (6.7 in) to the right. Direct damage down the left side extended from the front left bumper corner to the left front fender and measured 50.0 cm (19.7 in). The Field L extended from bumper corner to bumper corner and measured 160.0 cm (63.0 in) (**Figure 3**). Six crush measurements were calculated at bumper level as follows: $C_1 = 3.0$ cm (1.2 in), $C_2 = 0$ cm, $C_3 = 0$ cm, $C_4 = 0$ cm, $C_5 = 0$ cm, $C_6 = 0$ cm. Maximum

crush was located at C₁ and the Collision Deformation Classification (CDC) for the Chevrolet in Event 1 was 12FLEE3.

Figure 3. Front plane crush measurements, 2015 Chevrolet Cruze

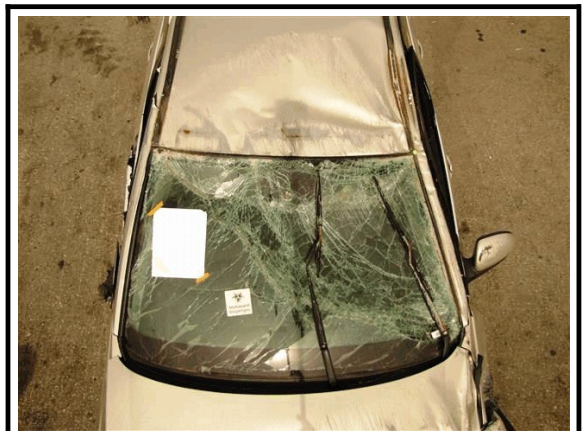
For the rollover, direct damage was present on the top plane beginning at the leading edge of the hood and extending rearward 251.0 cm (98.8 in) ending at the roof lateral to the B-pillar (**Figure 4**). Laterally, the damage was distributed from roof side rail to roof side rail measuring 118.0 cm (47.2 in). Maximum vertical and lateral crush were both located at the front left corner of the roof where it met the A-pillar. Maximum vertical crush measured 12.0 cm (4.7 in) and maximum lateral crush measured 4.0 cm (1.6 in). The CDC for Event 2 was 00TYDO2.

Figure 4. Top plane damage, 2015 Chevrolet Cruze

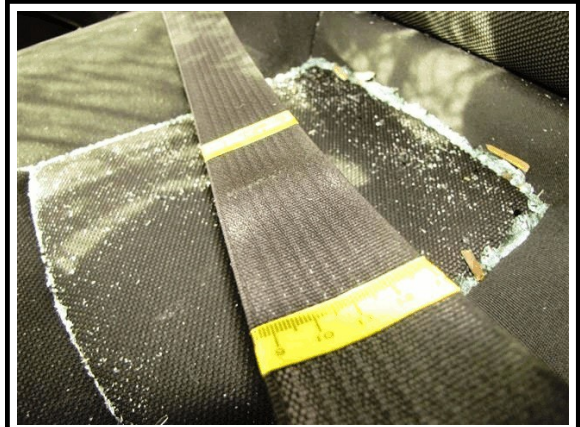
The Chevrolet's interior was equipped with forward seating for five occupants and all seats were configured with three-point lap and shoulder seat belts. The front row belts were equipped with retractor pretensioners, sliding latch plates and adjustable D-rings. The driver's belt was configured with an emergency locking retractor (ELR) and the driver's D-ring was adjusted to the middle position. The driver's lap and shoulder belt exhibited evidence of historical usage and was used during the crash. The pretensioner was actuated with the belt locked in the extended position. The webbing revealed evidence of driver loading with scuff marks located near the latch plate beginning 30.0 cm (11.8 in) above the stop button and near the D-ring beginning 112.0 cm (44.1 in) above the stop button (**Figure 5**). The front right passenger lap and shoulder belt pretensioner was actuated with the belt locked in the stowed position.

Figure 5. Driver loading evidence on seat belt, 2015 Chevrolet Cruze

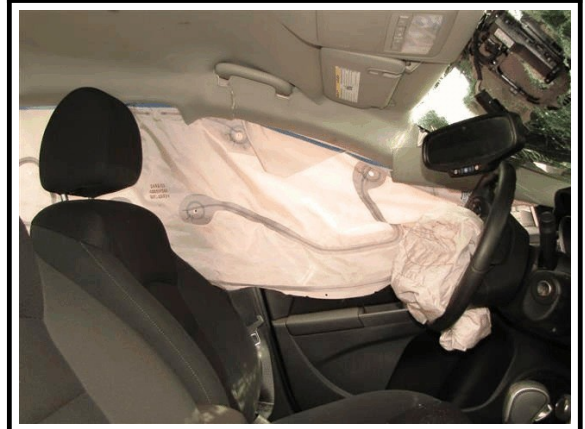
The driver's knee air bag deployed during the frontal impact from the lower left instrument panel below the steering column. This air bag measured 43.0 cm (16.9 in) in width and 24.0 cm (9.5 in) in length. It was unremarkable and likely loaded by the driver's knees at impact. The left IC air bag deployed during the rollover from the left roof side rail over the front and second rows (**Figure 6**). It was generally oval in shape measuring 170.0 cm (66.9 in) in width and 54.0 cm (21.3 in) in length. The air bag was configured with a tether measuring 20.0 cm (7.9 in) at its forward aspect connecting the air bag to the A-pillar. The air bag hung in its

post-impact deflated state 18.0 cm (7.1 in) below the side glass. The air bag covered the area of second row side glass entirely and covered the area of front row side glass with the exception of gap measuring 20.0 cm (7.8 in) x 15.0 cm (5.9 in) below the tether and aft of the A-pillar at the forward-most aspect.

Figure 6. Deployed left IC air bag, 2015 Chevrolet Cruze

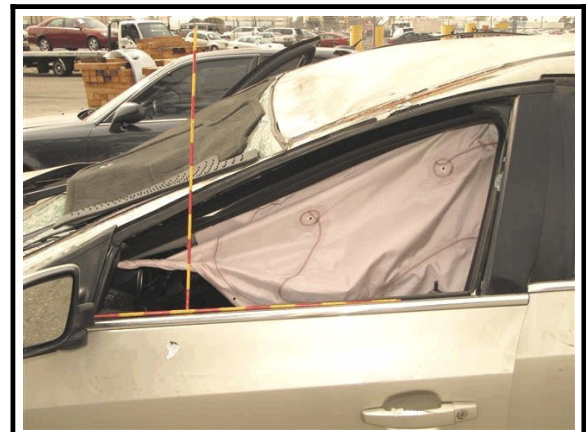
The right IC air bag was configured identically to the left. Both IC air bags appeared to have deployed normally. The left and right side glass in the front row disintegrated during the crash. It is noteworthy that the deployed IC air bags were not damaged by the disintegrated glass or by contact with the roadway during the rollover. The seat-mounted side impact air bags did not deploy.

Figure 7. Deployed left IC air bag, area of coverage and tether location on A-pillar, 2015 Chevrolet Cruze

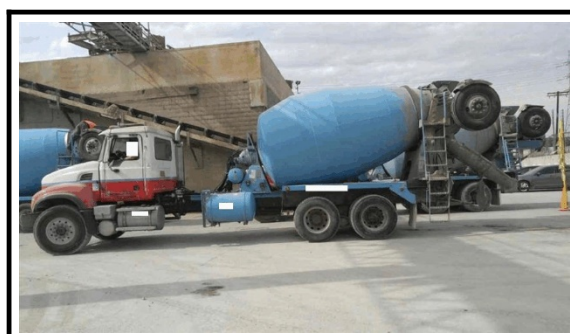
Figure 9. 2001 Mack CV500 left side view (owner image)

The 2001 Mack CV500 (**Figures 8 and 9**) was identified by the Vehicle Identification No. 1M2AG03C81Mxxxxxx. The Mack was a medium-heavy single-unit straight truck cement mixer in a four-axle configuration and a GVWR greater than 4,536 kg (10,000 lb). It was equipped with a Mack E7-350 diesel engine and air brakes.

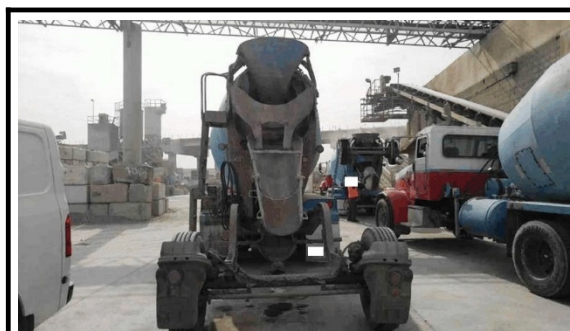
Figure 8. 2001 Mack CV500 back view (owner image)

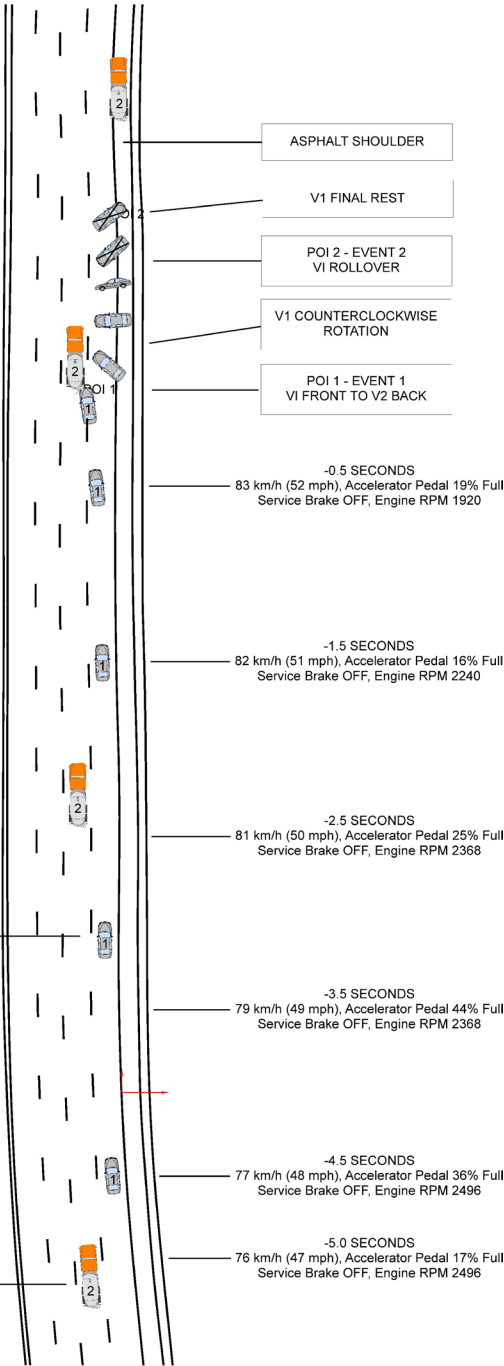
CRASH DIAGRAM

ROLLOVER INVESTIGATION
CALIFORNIA
DECEMBER 2015
N/B INTERSTATE HIGHWAY
V1: 2015 CHEVROLET CRUZE
V2: 2001 MACK CV500 WITH TRAILER
CONDITIONS: DUSK, CLEAR & DRY
SPEED LIMIT: 106 km/h (65 mph)

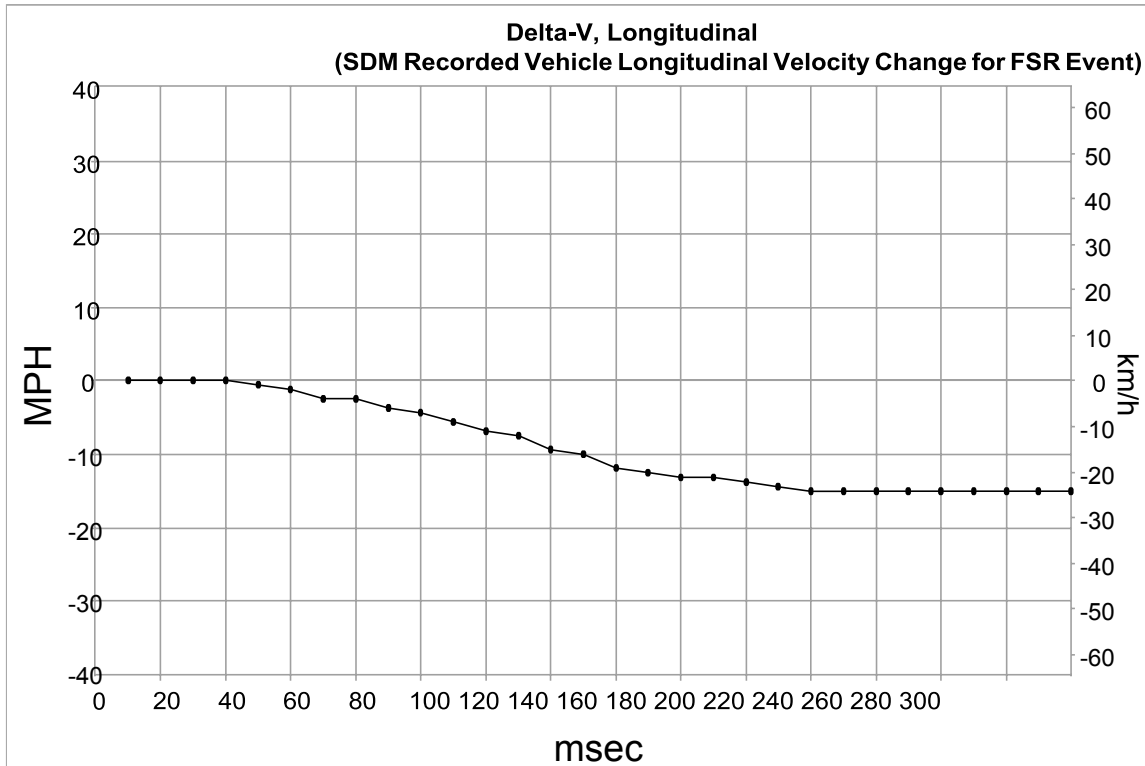
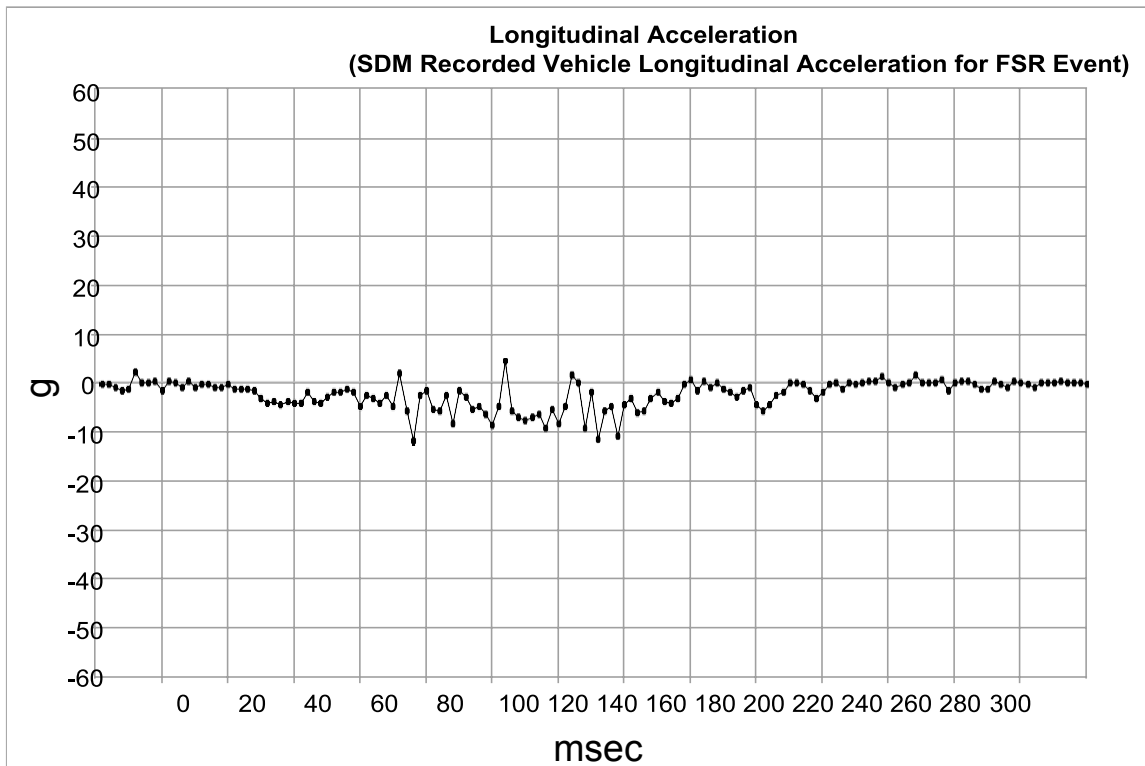
Time (msec)	Delta-V, Longitudinal (SDM Recorded Vehicle Longitudinal Velocity Change for FSR Event) (MPH)	Delta-V, Longitudinal (SDM Recorded Vehicle Longitudinal Velocity Change for FSR Event) (km/h)
10	0.0	0.0
20	0.0	0.0
30	0.0	0.0
40	0.0	0.0
50	-0.6	-1.0
60	-1.2	-2.0
70	-2.5	-4.0
80	-2.5	-4.0
90	-3.7	-6.0
100	-4.3	-7.0
110	-5.6	-9.0
120	-6.8	-11.0
130	-7.5	-12.0
140	-9.3	-15.0
150	-9.9	-16.0
160	-11.8	-19.0
170	-12.4	-20.0
180	-13.0	-21.0
190	-13.0	-21.0
200	-13.7	-22.0
210	-14.3	-23.0
220	-14.9	-24.0
230	-14.9	-24.0
240	-14.9	-24.0
250	-14.9	-24.0
260	-14.9	-24.0
270	-14.9	-24.0
280	-14.9	-24.0
290	-14.9	-24.0
300	-14.9	-24.0

Time (msec)	Longitudinal Acceleration (SDM Recorded Vehicle Longitudinal Acceleration for FSR Event) (g)	Time (msec)	Longitudinal Acceleration (SDM Recorded Vehicle Longitudinal Acceleration for FSR Event) (g)	Time (msec)	Longitudinal Acceleration (SDM Recorded Vehicle Longitudinal Acceleration for FSR Event) (g)
2	-0.6	102	-5.4	202	-5.8
4	-0.6	104	-5.8	204	-4.6
6	-1.0	106	-2.6	206	-2.6
8	-1.8	108	-8.2	208	-2.2
10	-1.4	110	-1.8	210	-0.2
12	2.2	112	-3.0	212	-0.2
14	-0.2	114	-5.4	214	-0.6
16	-0.2	116	-5.0	216	-1.8
18	0.2	118	-6.6	218	-3.4
20	-1.8	120	-8.6	220	-2.2
22	0.2	122	-5.0	222	-0.6
24	-0.2	124	4.2	224	-0.2
26	-1.0	126	-5.8	226	-1.4
28	0.2	128	-7.0	228	-0.2
30	-1.0	130	-7.8	230	-0.6
32	-0.6	132	-7.0	232	-0.2
34	-0.6	134	-6.6	234	0.2
36	-1.0	136	-9.4	236	0.2
38	-1.0	138	-5.4	238	1.0
40	-0.6	140	-8.2	240	-0.2
42	-1.4	142	-5.0	242	-1.0
44	-1.4	144	1.4	244	-0.6
46	-1.4	146	-0.2	246	-0.2
48	-1.8	148	-9.4	248	1.4
50	-3.4	150	-2.2	250	-0.2

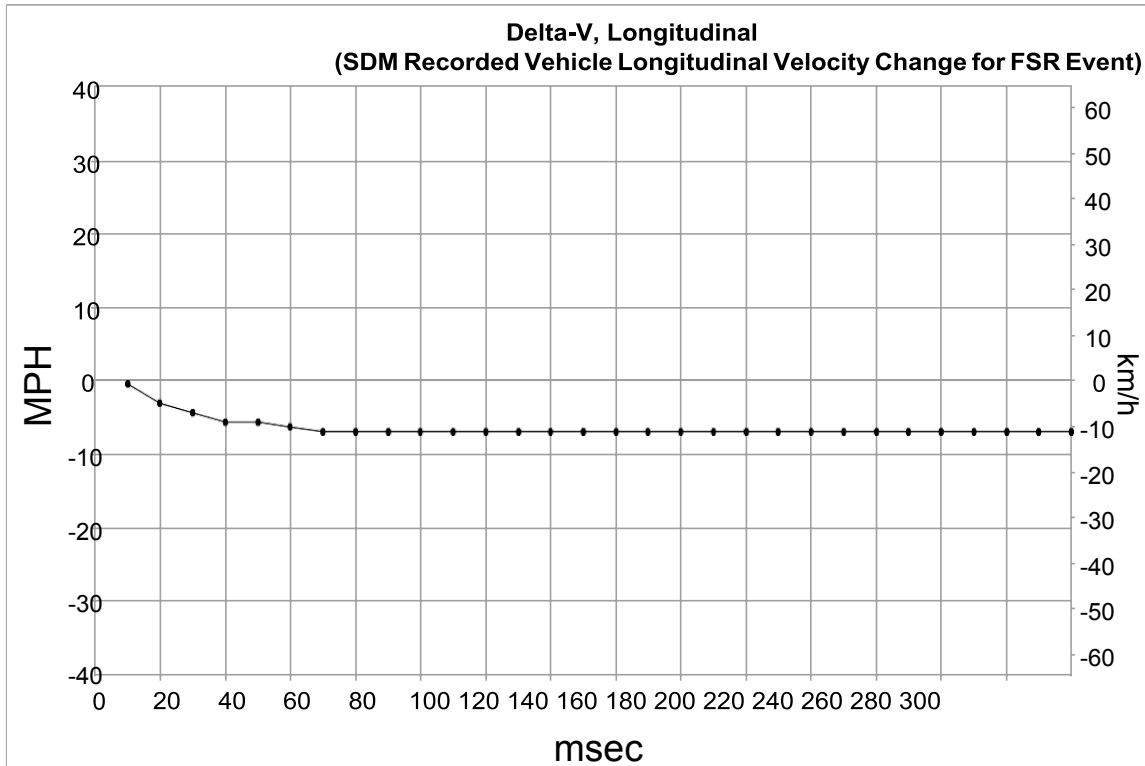
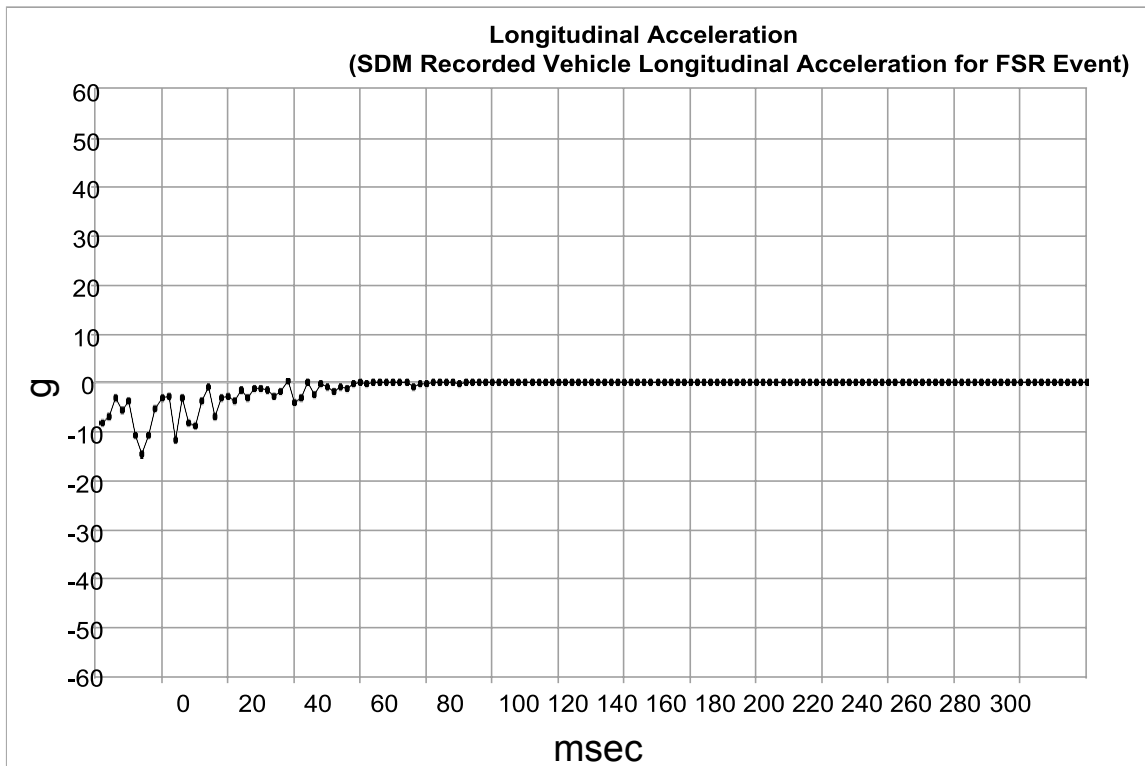
Time (msec)	Delta-V, Longitudinal (SDM Recorded Vehicle Longitudinal Velocity Change for FSR Event) (MPH)	Delta-V, Longitudinal (SDM Recorded Vehicle Longitudinal Velocity Change for FSR Event) (km/h)
10	-0.6	-1.0
20	-3.1	-5.0
30	-4.3	-7.0
40	-5.6	-9.0
50	-5.6	-9.0
60	-6.2	-10.0
70	-6.8	-11.0
80	-6.8	-11.0
90	-6.8	-11.0
100	-6.8	-11.0
110	-6.8	-11.0
120	-6.8	-11.0
130	-6.8	-11.0
140	-6.8	-11.0
150	-6.8	-11.0
160	-6.8	-11.0
170	-6.8	-11.0
180	-6.8	-11.0
190	-6.8	-11.0
200	-6.8	-11.0
210	-6.8	-11.0
220	-6.8	-11.0
230	-6.8	-11.0
240	-6.8	-11.0
250	-6.8	-11.0
260	-6.8	-11.0
270	-6.8	-11.0
280	-6.8	-11.0
290	-6.8	-11.0
300	-6.8	-11.0

Time (msec)	Longitudinal Acceleration (SDM Recorded Vehicle Longitudinal Acceleration for FSR Event) (g)	Time (msec)	Longitudinal Acceleration (SDM Recorded Vehicle Longitudinal Acceleration for FSR Event) (g)	Time (msec)	Longitudinal Acceleration (SDM Recorded Vehicle Longitudinal Acceleration for FSR Event) (g)
2	-8.2	102	-0.2	202	-0.2
4	-7.0	104	-0.2	204	-0.2
6	-3.4	106	-0.2	206	-0.2
8	-5.8	108	-0.2	208	-0.2
10	-3.8	110	-0.6	210	-0.2
12	-11.0	112	-0.2	212	-0.2
14	-14.6	114	-0.2	214	-0.2
16	-11.0	116	-0.2	216	-0.2
18	-5.4	118	-0.2	218	-0.2
20	-3.4	120	-0.2	220	-0.2
22	-3.0	122	-0.2	222	-0.2
24	-11.8	124	-0.2	224	-0.2
26	-3.4	126	-0.2	226	-0.2
28	-8.2	128	-0.2	228	-0.2
30	-9.0	130	-0.2	230	-0.2
32	-3.8	132	-0.2	232	-0.2
34	-1.0	134	-0.2	234	-0.2
36	-7.0	136	-0.2	236	-0.2
38	-3.4	138	-0.2	238	-0.2
40	-3.0	140	-0.2	240	-0.2
42	-3.8	142	-0.2	242	-0.2
44	-1.8	144	-0.2	244	-0.2
46	-3.4	146	-0.2	246	-0.2
48	-1.4	148	-0.2	248	-0.2

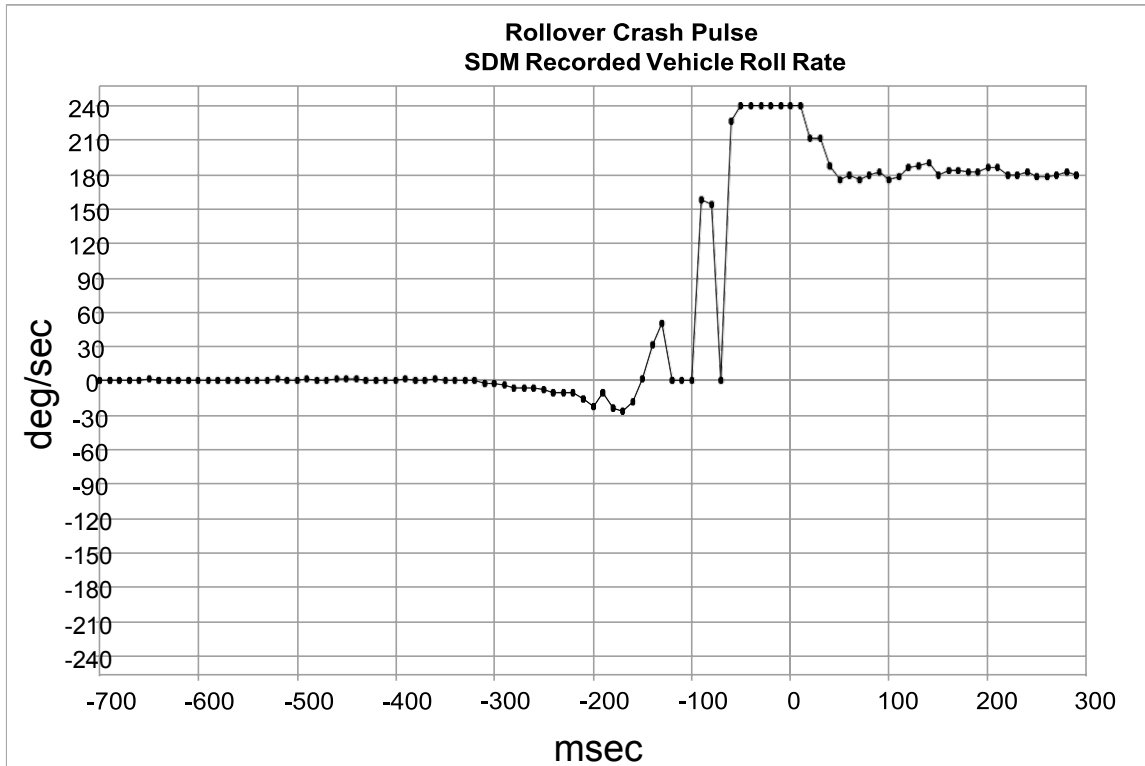
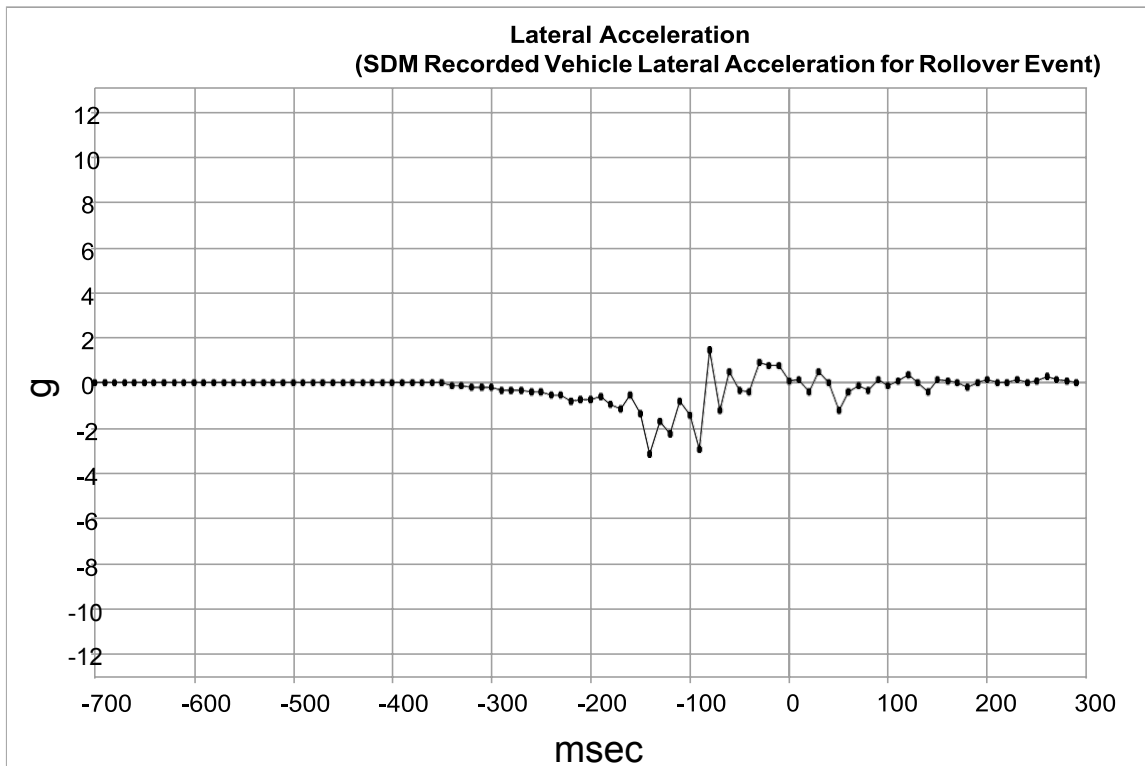
Time (msec)	SDM Recorded Vehicle Roll Rate (deg/sec)	Time (msec)	SDM Recorded Vehicle Roll Rate (deg/sec)
-700	0	-200	-22
-690	0	-190	-10
-680	0	-180	-24
-670	0	-170	-26
-660	0	-160	-18
-650	2	-150	2
-640	0	-140	32
-630	0	-130	50
-620	0	-120	0
-610	0	-110	0
-600	0	-100	0
-590	0	-90	158
-580	0	-80	154
-570	0	-70	0
-560	0	-60	226
-550	0	-50	240
-540	0	-40	240
-530	0	-30	240
-520	2	-20	240
-510	0	-10	240
-500	0	0	240
-490	2	10	240
-480	0	20	212
-470	0	30	212
-460	2	40	188
-450	2	50	176
-440	2	60	180
-430	0	70	176
-420	0	80	180
-410	0	90	182
-400	0	100	176
-390	2	110	178
-380	0	120	186
-370	0	130	188
-360	2	140	190
-350	0	150	180
-340	0	160	184
-330	0	170	184
-320	0	180	182
-310	-2	190	182
-300	-2	200	186
-290	-4	210	186
-280	-6	220	180
-270	-6	230	180
-260	-6	240	182
-250	-8	250	178
-240	-10	260	178
-230	-10	270	180
-220	-10	280	182
-210	-16	290	180

Time (msec)	Lateral Acceleration (SDM Recorded Vehicle Lateral Acceleration for Rollover Event) (g)	Time (msec)	Lateral Acceleration (SDM Recorded Vehicle Lateral Acceleration for Rollover Event) (g)
-700	0.0	-200	-0.7
-690	0.0	-190	-0.6
-680	0.0	-180	-0.9
-670	0.0	-170	-1.1
-660	0.0	-160	-0.5
-650	0.0	-150	-1.3
-640	0.0	-140	-3.1
-630	0.0	-130	-1.7
-620	0.0	-120	-2.2
-610	0.0	-110	-0.8
-600	0.0	-100	-1.4
-590	0.0	-90	-2.9
-580	0.0	-80	1.5
-570	0.0	-70	-1.2
-560	0.0	-60	0.5
-550	0.0	-50	-0.3
-540	0.0	-40	-0.4
-530	0.0	-30	0.9
-520	0.0	-20	0.8
-510	0.0	-10	0.8
-500	0.0	0	0.1
-490	0.0	10	0.2
-480	0.0	20	-0.4
-470	0.0	30	0.5
-460	0.0	40	0.0
-450	0.0	50	-1.2
-440	0.0	60	-0.4
-430	0.0	70	-0.1
-420	0.0	80	-0.3
-410	0.0	90	0.2
-400	0.0	100	-0.1
-390	0.0	110	0.1
-380	0.0	120	0.4
-370	0.0	130	0.0
-360	0.0	140	-0.4
-350	0.0	150	0.2
-340	-0.1	160	0.1
-330	-0.1	170	0.0
-320	-0.2	180	-0.2
-310	-0.2	190	0.0
-300	-0.2	200	0.2
-290	-0.3	210	0.0
-280	-0.3	220	0.0
