# Evaluation of Safety Systems Through Matched Comparison for Frontal, Side, and Knee Bolster Safety Systems

CIREN Public Meeting

October 2009

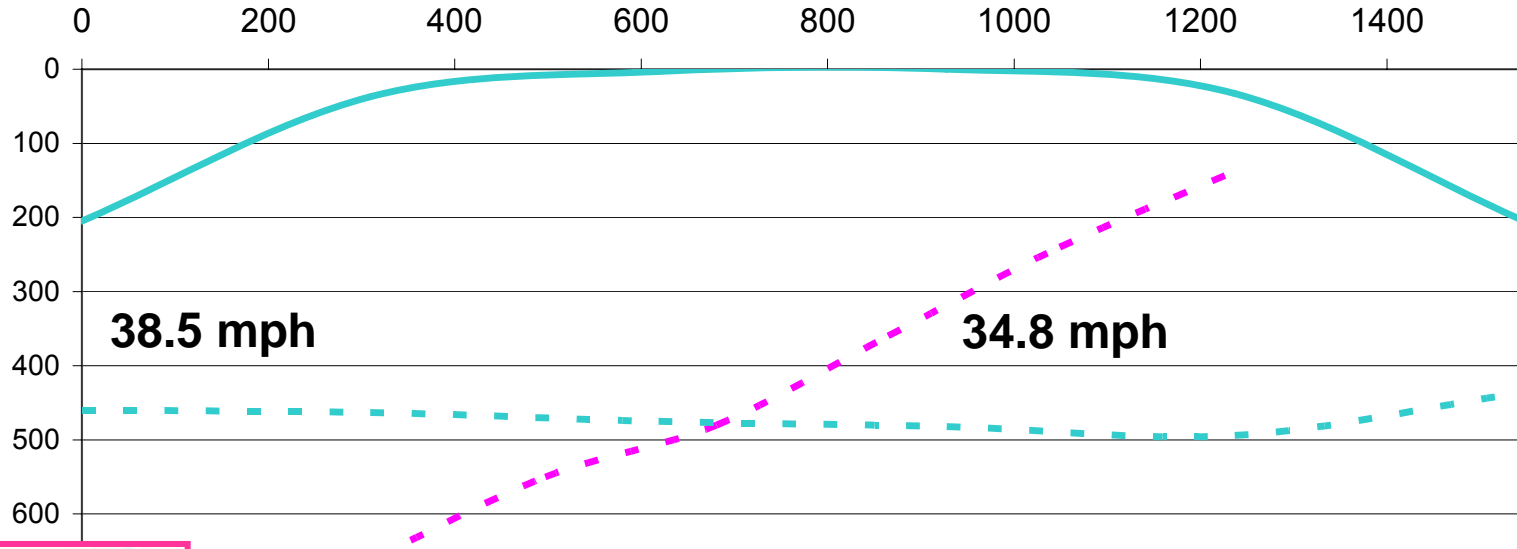
# Crush Profile Comparison

**38.5 mph**

**34.8 mph**

- - CIREN Crush   
 — Crash Test Free Space   
 - - Crash Test Crush

CIREN	NHTSA NCAP 4893
Max crush= 66 cm	Max crush= 48 cm

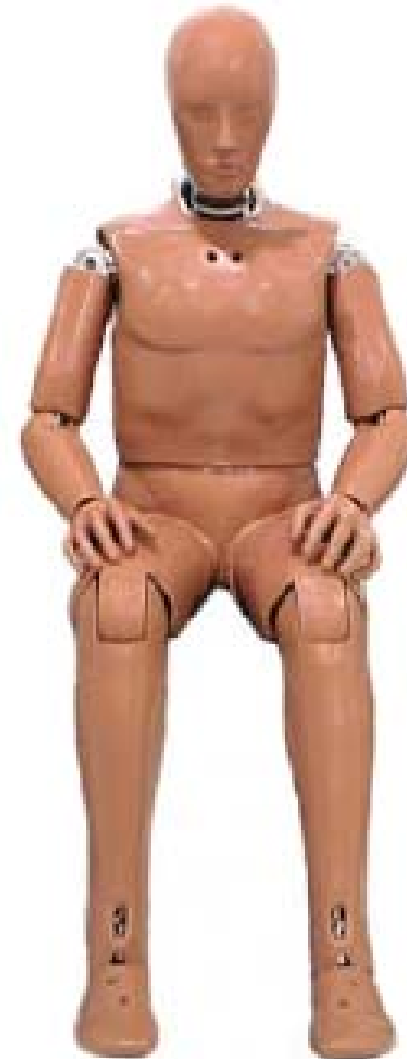
## IIII 50<sup>th</sup> % Male

5' 9" tall

172.3 lbs

Head: accelerometers to measure HIC

Neck: upper and lower load cells

Upper Extremity: humerus load cells

Torso: clavicle load cells, accelerometer to measure chest G's, deflection potentiometer

Lower Extremity: accelerometer in pelvis, femur load cells, knee slider potentiometers, tibia load cells, ankle and toe load cells

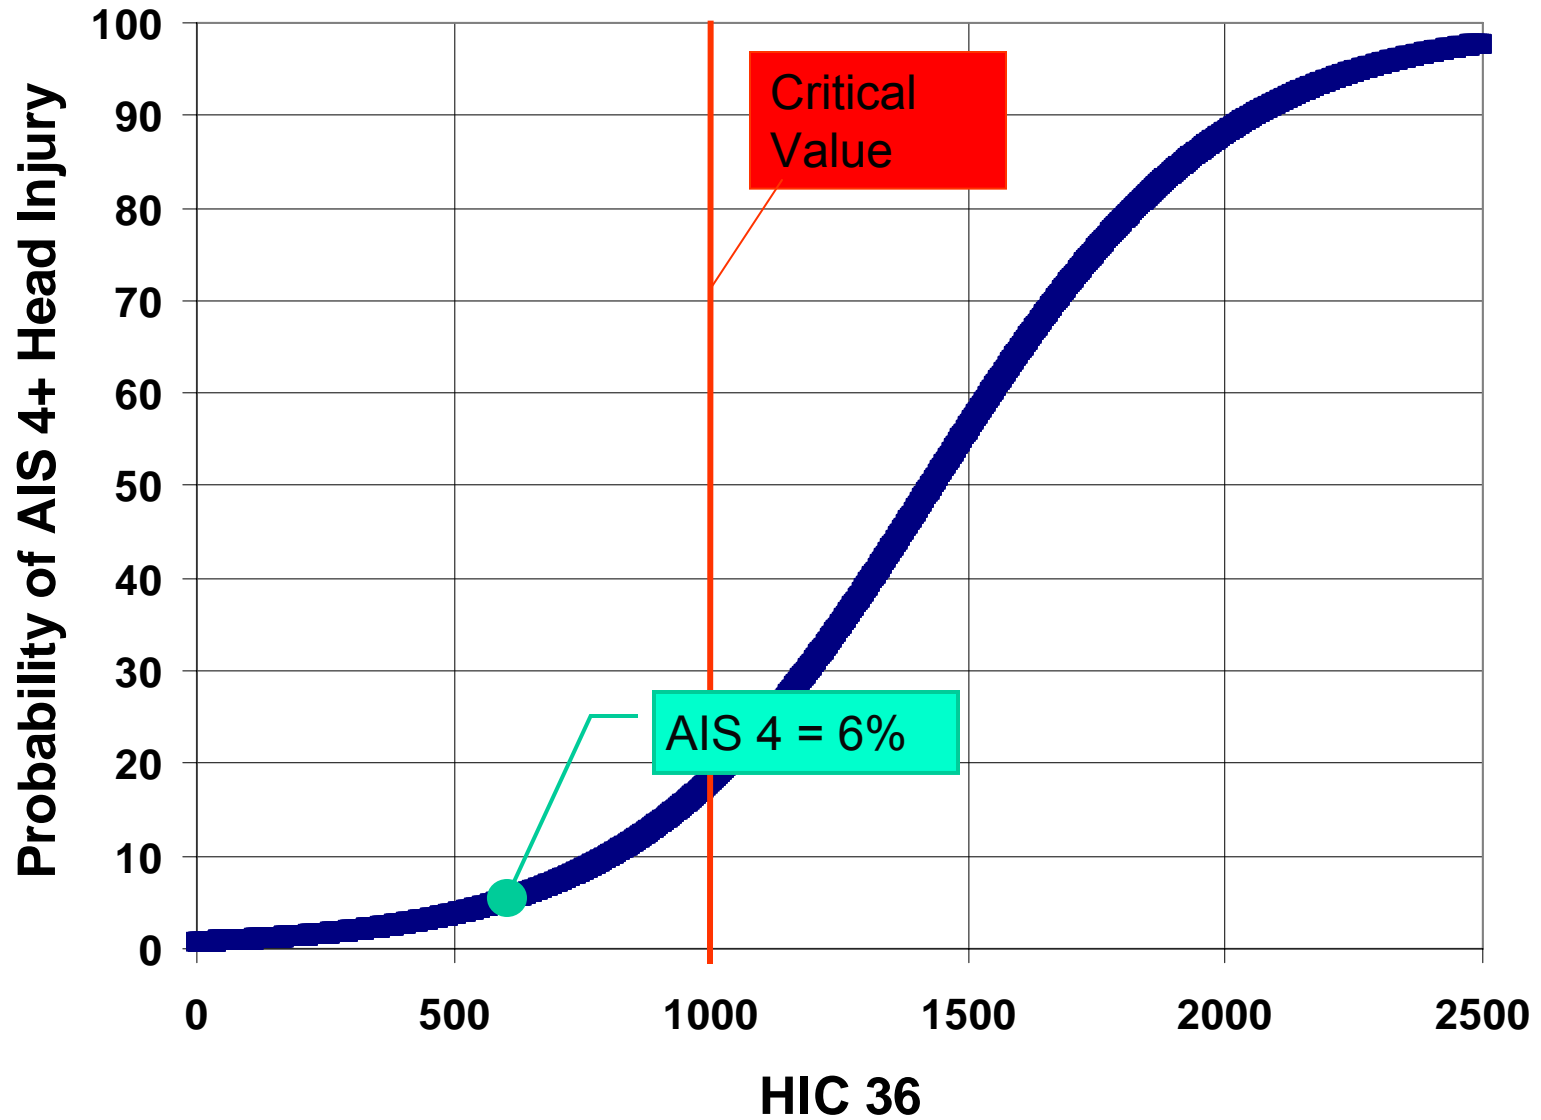
# HIC36 = 636.8

CIREN Occ – no head injury

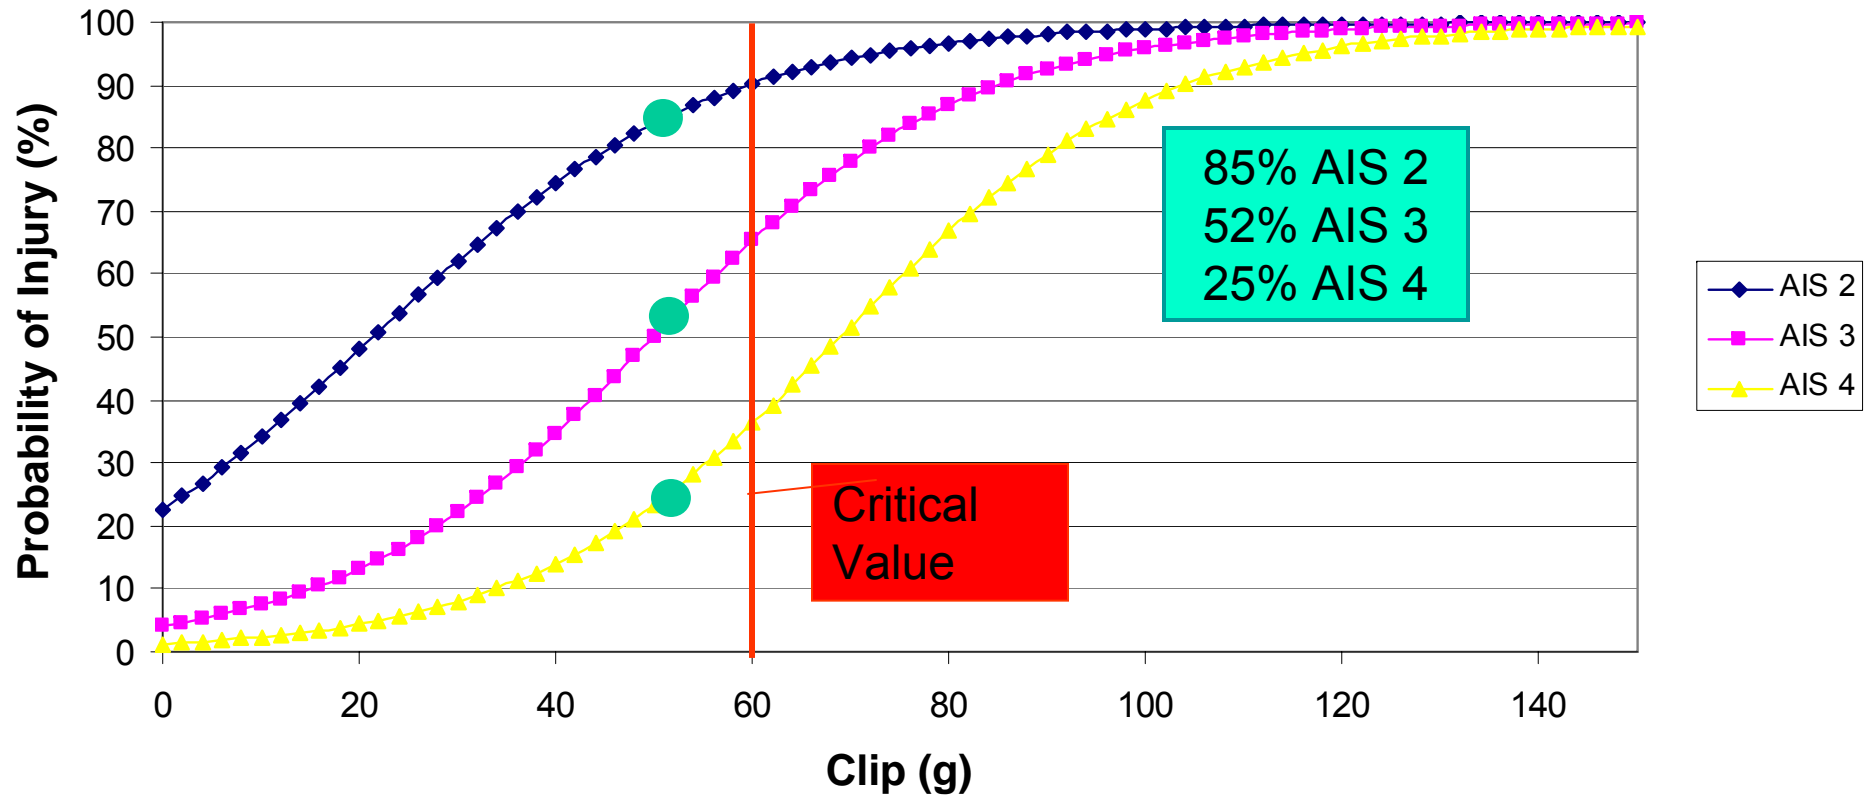
# Thoracic Injury Risk = 51.6 g's

Thoracic Injury Risk Curve

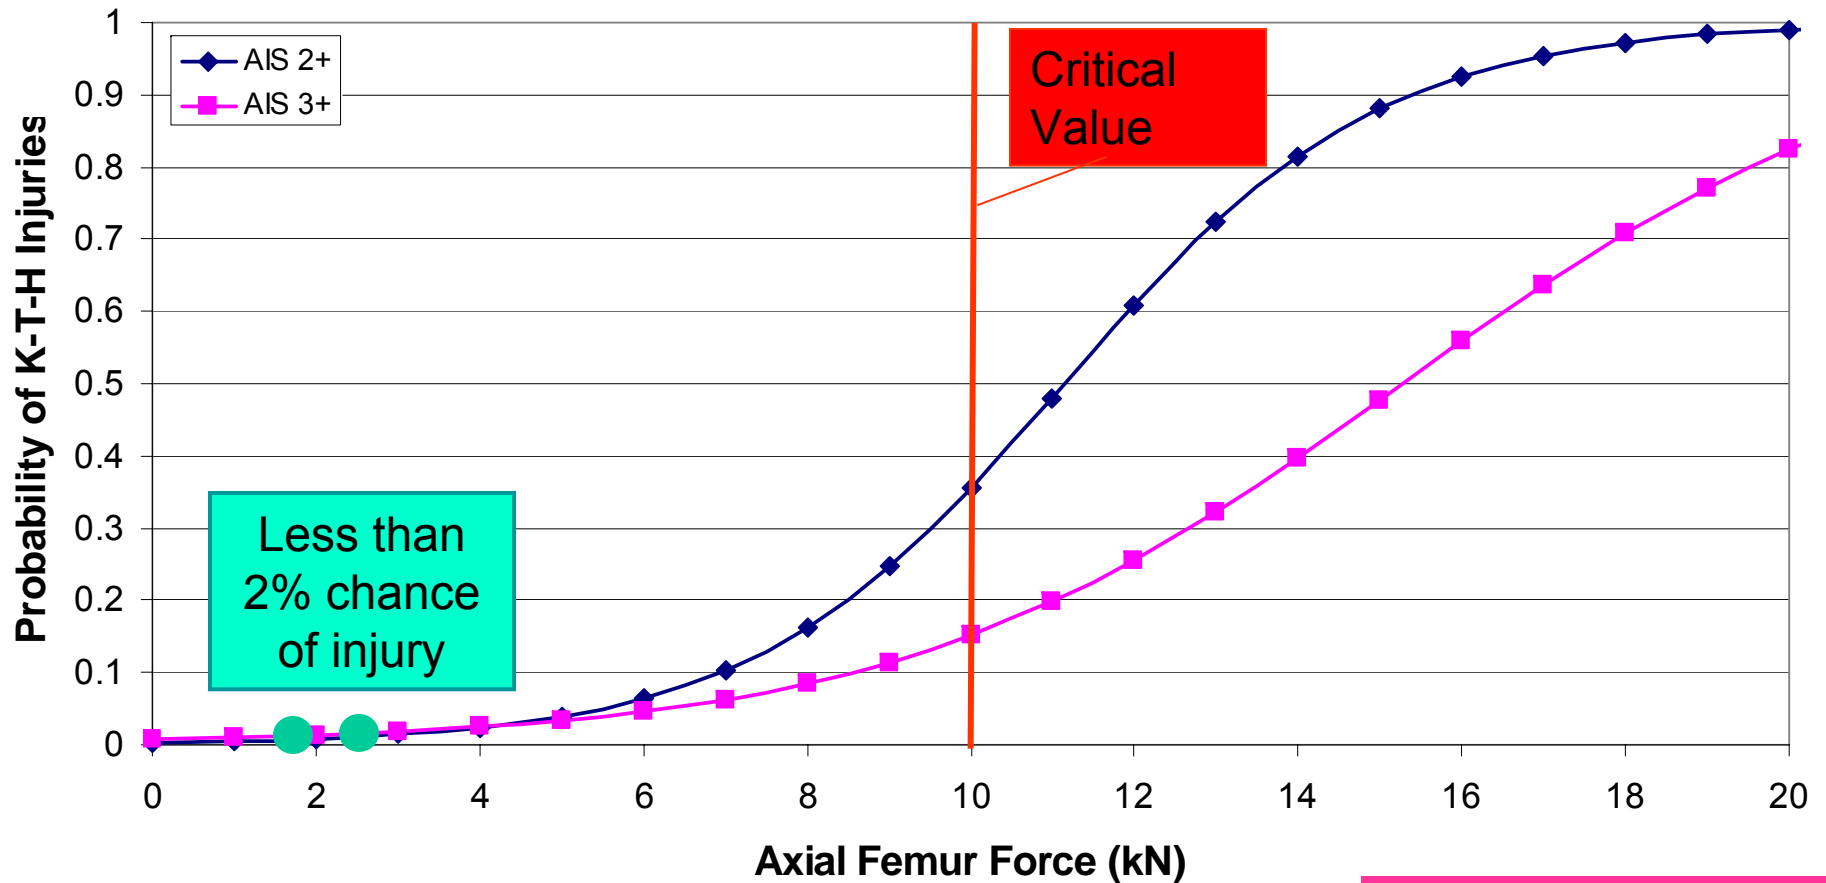
# K-T-H Injury Risk

Left = 1912 N, Right = 2557 N

CIREN Occ AIS 3  
Femur fractures  
Acetab fractures

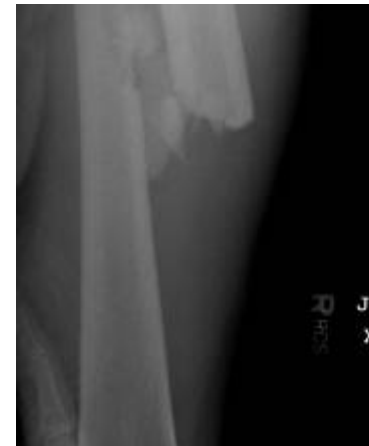
Right Femur Fx  
IPC: Knee bolster

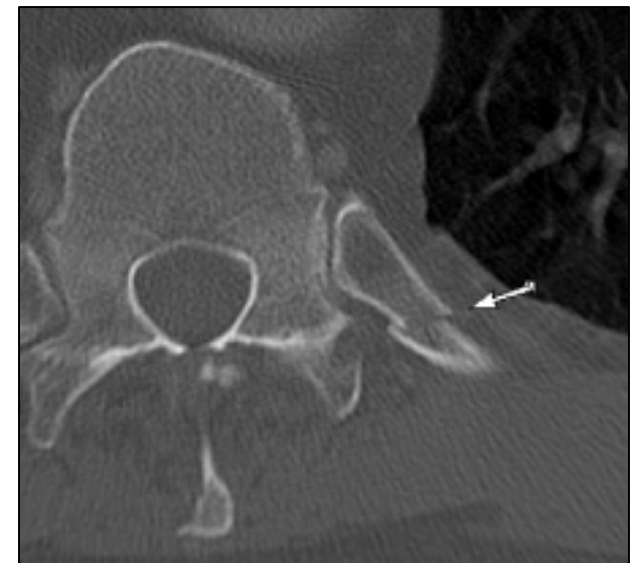
Rib fx  
IPC: Side AB
