Tanvir Tanim, Senior R&D Scientist and Group Lead
Energy Storage Technology Group, U.S. Department of Energy
Energy Storage and Electric Transportation

A Teardown Study of Flood Damaged Electric Vehicles

EV Battery Safety, Part 2

SAE Government/Industry Meeting
January 16-18, 2024, Washington, DC, USA

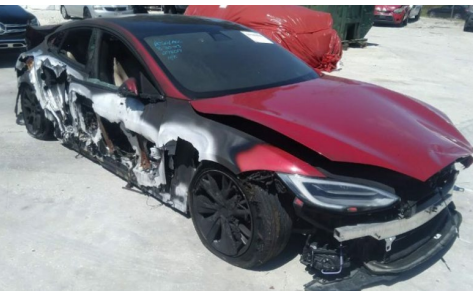
2022 EV Battery Fires at Florida after Hurricane Ian
