DOT HS 812 539

**Special Crash Investigations
Remote Vehicle Fire/
Child Restraint System Investigation
Vehicle: 2004 Chevrolet Silverado
Location: California
Crash Date: January 2014**

Special Crash Investigations
Remote Vehicle Fire/Child Restraint System
Investigation Case Number: DS16026
Vehicle: 2004 Chevrolet Silverado
Location: California
Incident Date: January 2014

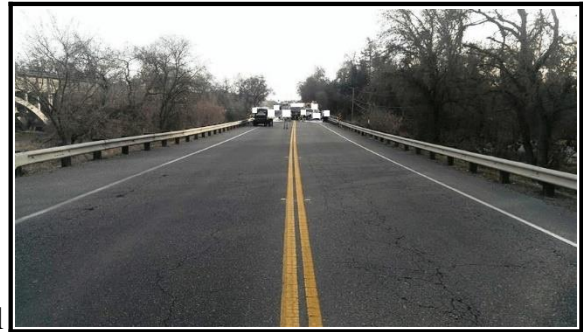
The crash occurred on a bridge section of an undivided north/south county-maintained roadway in California (**Figure 2**). Crash site data including roadway measurements were obtained from the police report, police on-scene images and satellite images. The roadway was asphalt surfaced and was configured with two lanes each measuring 3.7 m (12.0 ft) wide. It was configured with paved shoulders on the east and west edges measuring 1.8 m (6.0 ft) wide. The shoulders were bordered by metal bridge railings of unknown height. The travel lanes were separated by a solid double yellow painted stripe, the left edge was bordered by a solid yellow painted stripe and the right edge was bordered by a solid white painted fog line. This roadway was straight for the full length of the bridge. In their respective travel approaches across the bridge, the northbound and southbound lanes had a slight ascending slope that crested at the center of the bridge. The posted speed limit was 89 km/h (55 mph). The investigating police officer noted no unusual conditions were present at the time of the crash.

Figure 2. Crash site looking south (police image)

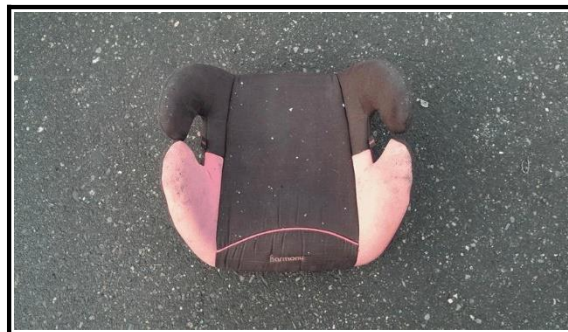
According to the owner's manual, the Cruz Youth Booster Seat (**Figure 7-8**) is a forward-facing only belt positioning booster safety seat intended to be used in combination with the vehicle's lap and shoulder seat belt. It was configured with a molded plastic shell, fabric seat pad and pre-installed shoulder belt guide. It is unknown whether the shoulder belt guide was attached or in use at the time of the crash.

Figure 7. Harmony Juvenile Cruz Youth Booster Seat, top view, 2004 Chevrolet Silverado
