The Automated Collision Notification System

INTRODUCTION

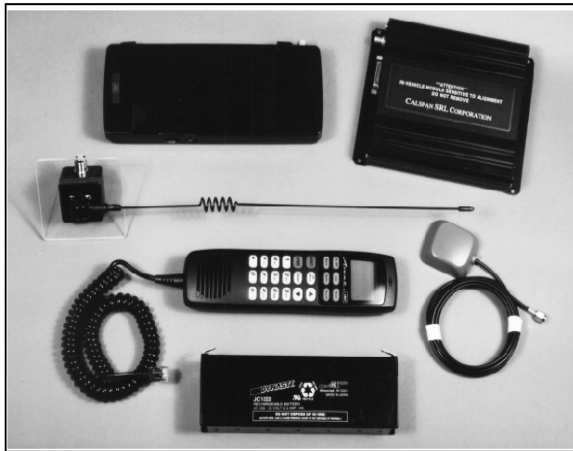
The components of the ACN in-vehicle equipment suite are illustrated in Figure 2. These components include: the Veridian developed In-Vehicle Module (IVM), the cellular telephone handset, the cellular telephone transceiver (3 Watt), the back-up battery, and the associated antennas.

Figure 2: ACN In-vehicle Hardware

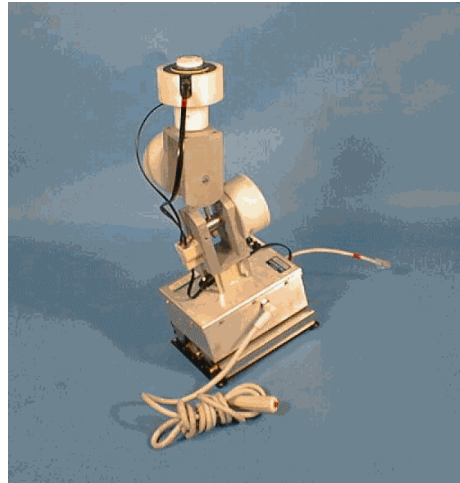
ACN in-vehicle equipment installed into their vehicles by Cell-One who also provided the cellular telephone service. In most cases the equipment was installed under the rear seat. The In-Vehicle Module (IVM) is calibrated in place after installation, using a reference correction unit (see Figure 9), such that the triaxial accelerometer output is in the standard SAE Cartesian vehicle coordinate system regardless of the vehicle or the installation location. Several cellular telephone usage plans were offered by Cell-One to the participants; however, emergency calls and calls to Veridian are always free of charge to the participant. After a crash occurs the crash is investigated in depth. A time line listing crash time, notification times, dispatch times and response times is constructed and analyzed to identify the effect of the ACN time on response time.

Figure 9. Reference correction unit.

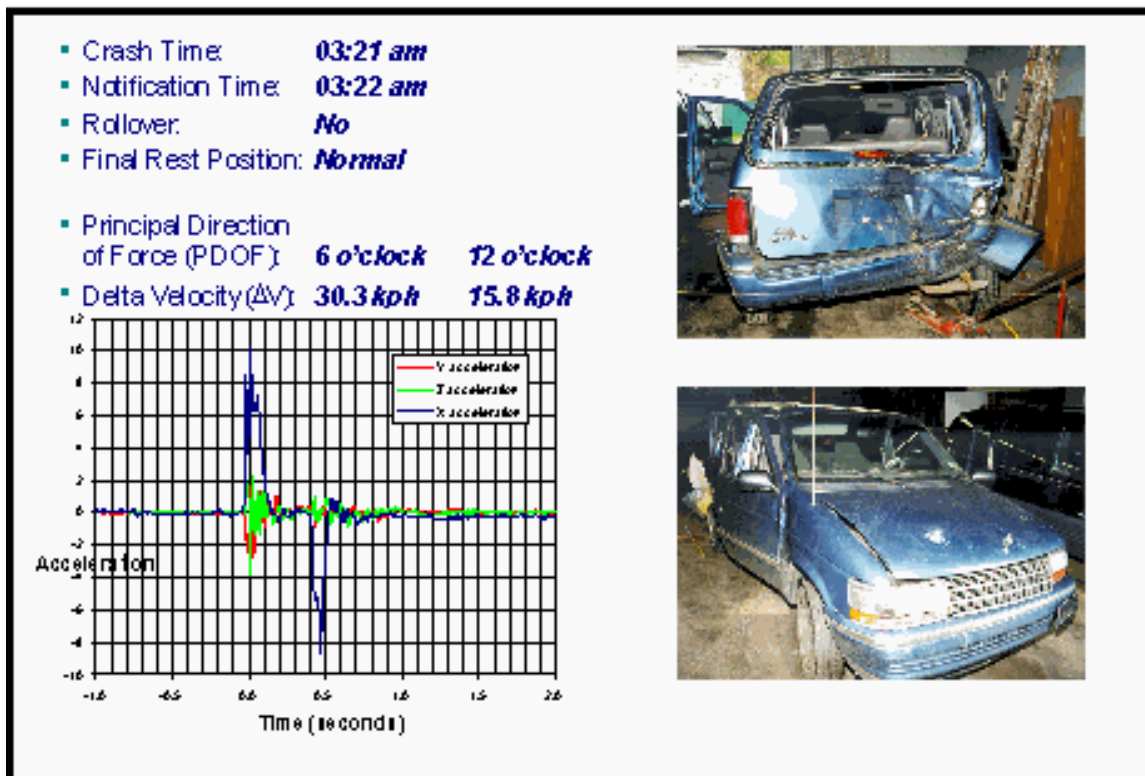
Crash I.D. #440-1109 involved an ACN equipped 1993 Plymouth Voyager mini-van that was struck from the rear while waiting at a red traffic signal. The mini-van was pushed forward and into the rear end of the vehicle waiting in front of it. The result was two collisions, a rear and a frontal, both of which exceeded the crash thresholds of the IVM. Figure 11 summarizes the crash, shows photographs of the mini-van and shows the triaxial accelerometer data recorded by the IVM and stored in flash memory. Both events are clearly seen in the acceleration time history as a positive x acceleration excursion (the rear crash) followed by a quiescent period and a negative x acceleration excursion (the frontal crash). The IVM calculates the crash delta velocity and the principal direction of force (PDOF) for each crash event, indicates whether a rollover occurred and determines the final rest position of the vehicle after the crash is over (see Figure 11). Figure 12 is a crash scene diagram showing the events of the crash as reconstructed by a crash investigator. The IVM obtains the same information as post-crash reconstruction and makes it immediately available to EMS, Police and Fire dispatchers to be used in the dispatch process.

Figure 11. Crash summary for ACN Crash No. 440-1109.
