Tanvir Tanim, Senior R&D Scientist and Group Lead
Energy Storage Technology Group, U.S. Department of Energy
Energy Storage and Electric Transportation

A Teardown Study of Flood Damaged Electric Vehicles

EV Battery Safety, Part 2

SAE Government/Industry Meeting
January 16-18, 2024, Washington, DC, USA

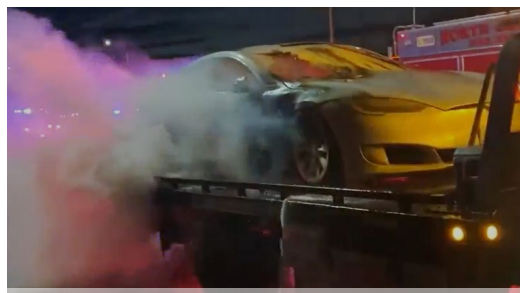
2022 EV Battery Fires at Florida after Hurricane Ian

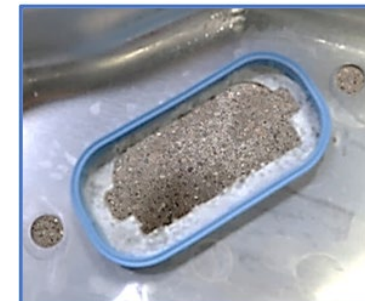
Key Observations- Pack Design 1: Tesla Model 3 & Y

- Distinct corrosion, contamination, water, and water marks on the floor of the penthouse and within several components for V3 (Tesla Model 3) were observed:
 - More specifically, corrosion was noted on the busbar connections, within connectors, on the uncoated aluminum housing of the charger/inverter module, and elsewhere
 - Contactors tested the open-circuit (normal) and found the pyro-fuse had not triggered.
- In this state, it is highly likely that the modules within the penthouse would be unable to function properly in any capacity.
